AEROSPACE – GROUP  
NATIONAL RESEARCH COUNCIL CANADA

## **Full-Scale Aircraft Fire Tests - A Comparison of Aluminium and Composite Burn-Through**

Report No: LTR-SMM-2015-0414

Date: May 2015

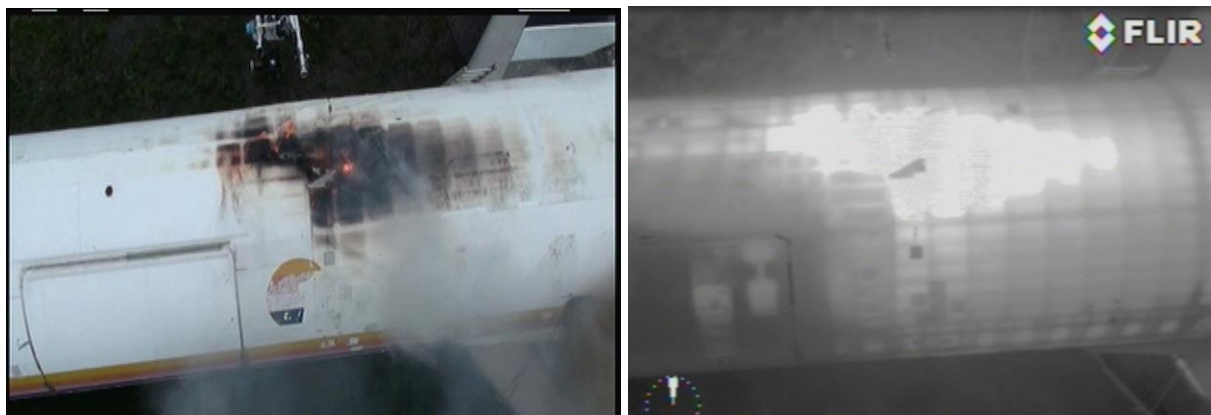
c) First flames visible at beginning of fuselage crown burn-through.

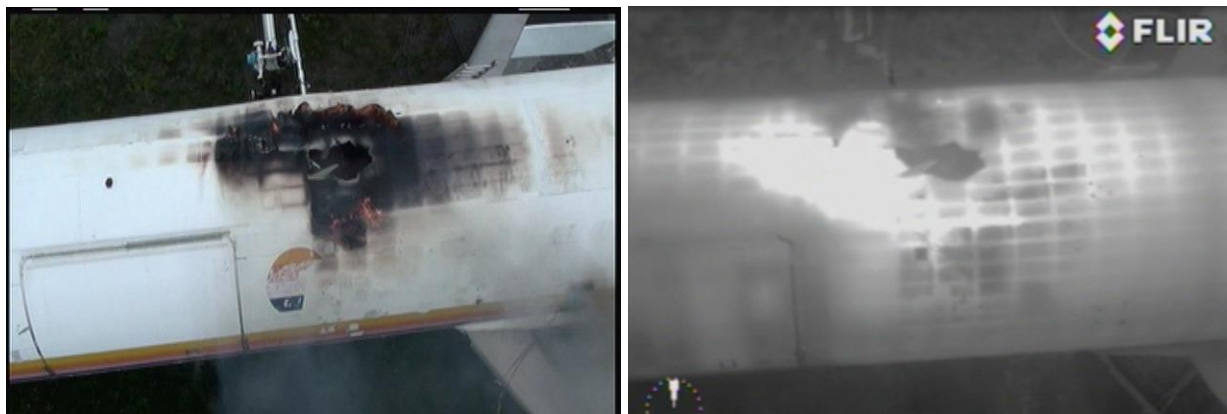
d) Just prior to first extinguishment with Stinger. Area of crown with TC#11 attached has melted.

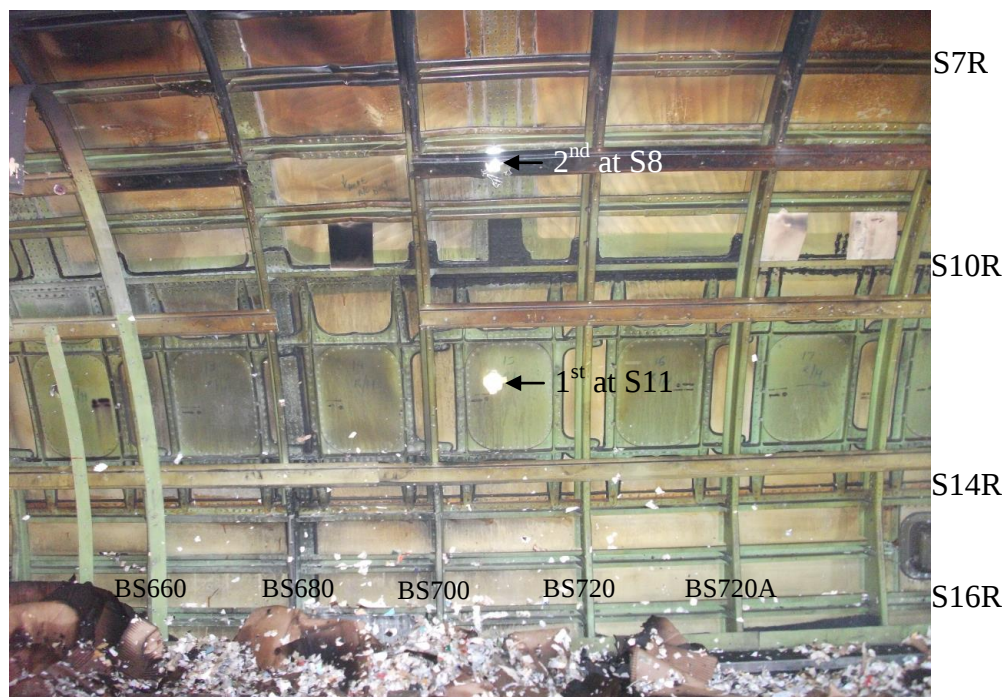
Figure 20 shows the interior view of the lower STBD side post-test including, Stinger piercings and clearly shows the lack of heat/soot damage at the seat of the fire. There is little heat damage below S6 or sooting below S8 on either side. The figure partially illustrates the unburnt fuel (paper) remaining.

Figure 20. Interior view of lower STBD side.

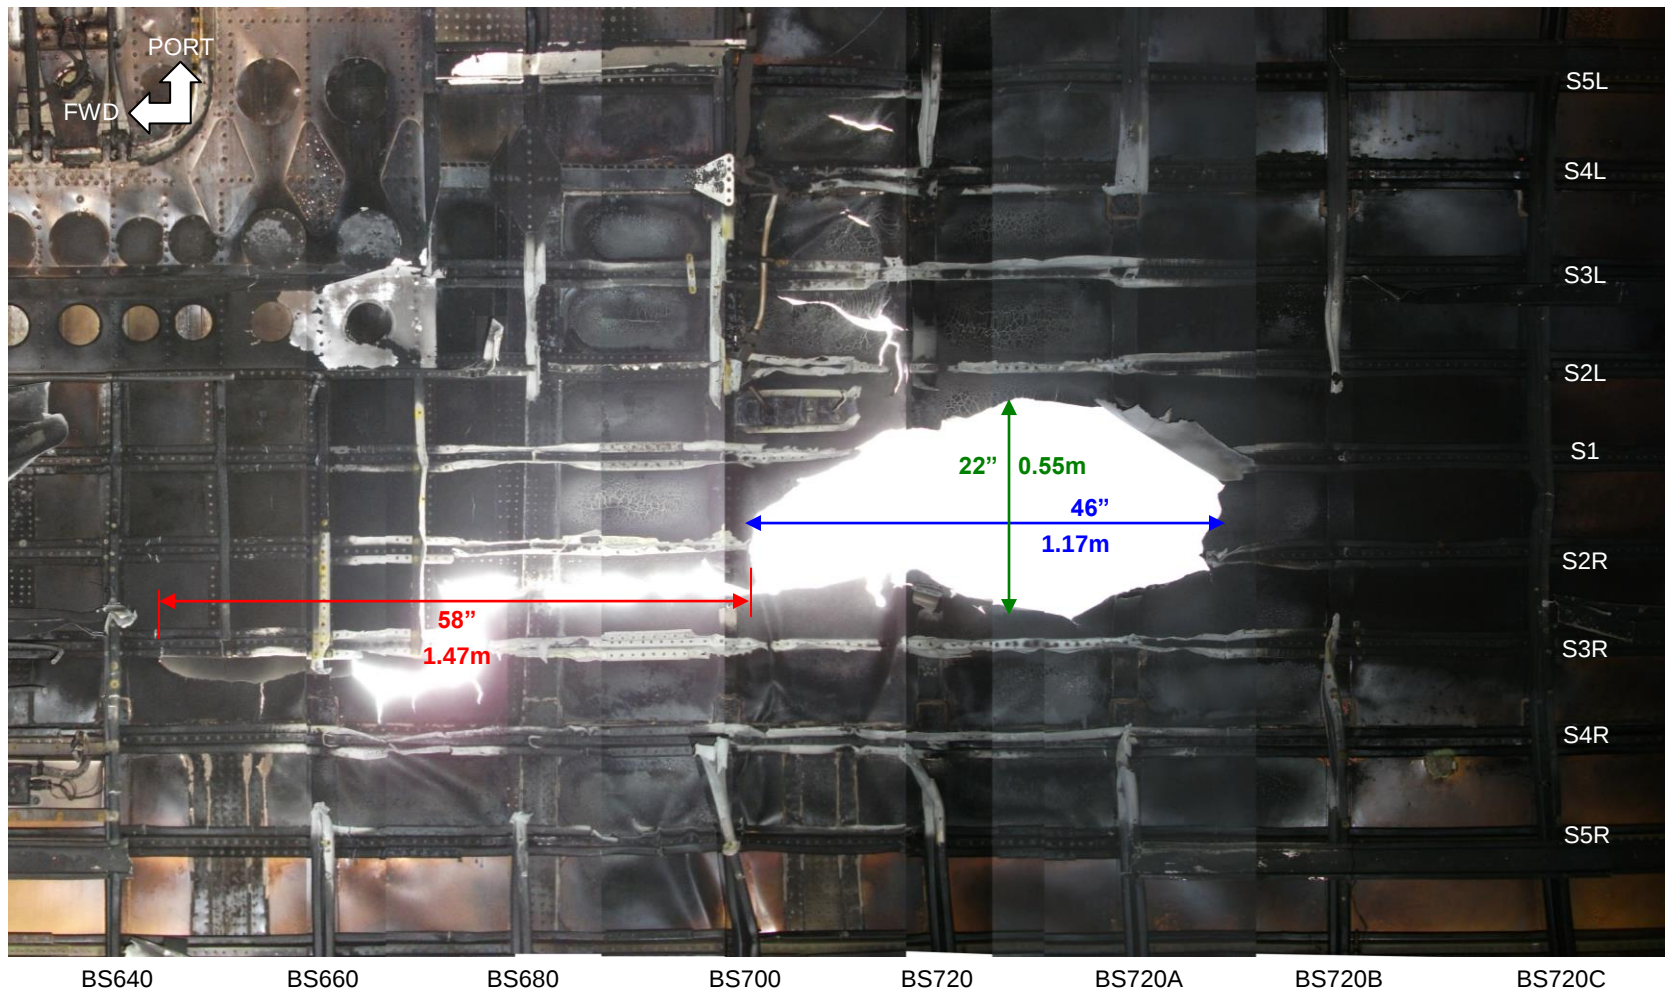
The extent of the burn-through is illustrated in Figure 23 which is a collage of images. The crown breach extends as a narrow split for 58 inches (1.47m) from BS640 to 700 where it widens to a maximum of 22 inches (0.55m) between S2L and S3R and is 104 inches (2.64m) long overall. From this the composite re-skinned area for Test 2, at 120 inches long (3m), was deemed appropriate. The frames at BS680 through 720B have been burned away to a maximum of S5R and S4L. There are a

Figure 23: Test 1 fuselage crown, post-test damage.

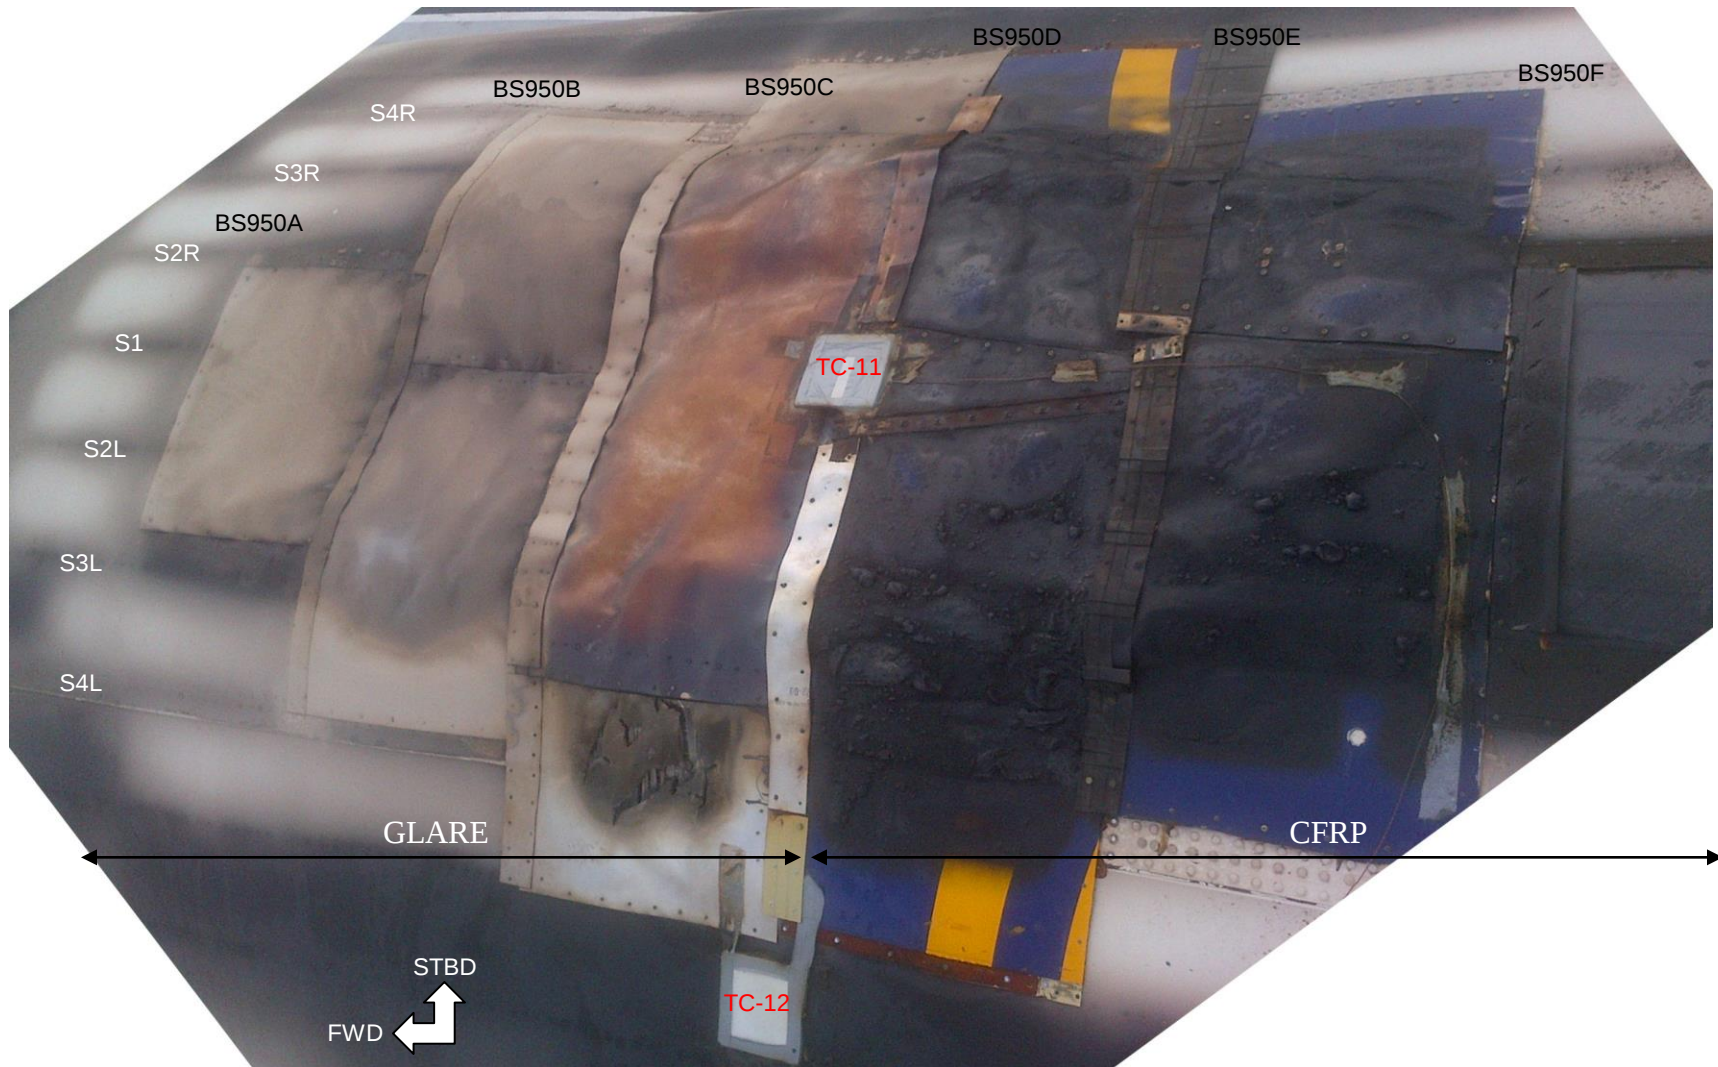
Figure 28. Test 2. Overall exterior view of the fuselage crown, post-test.

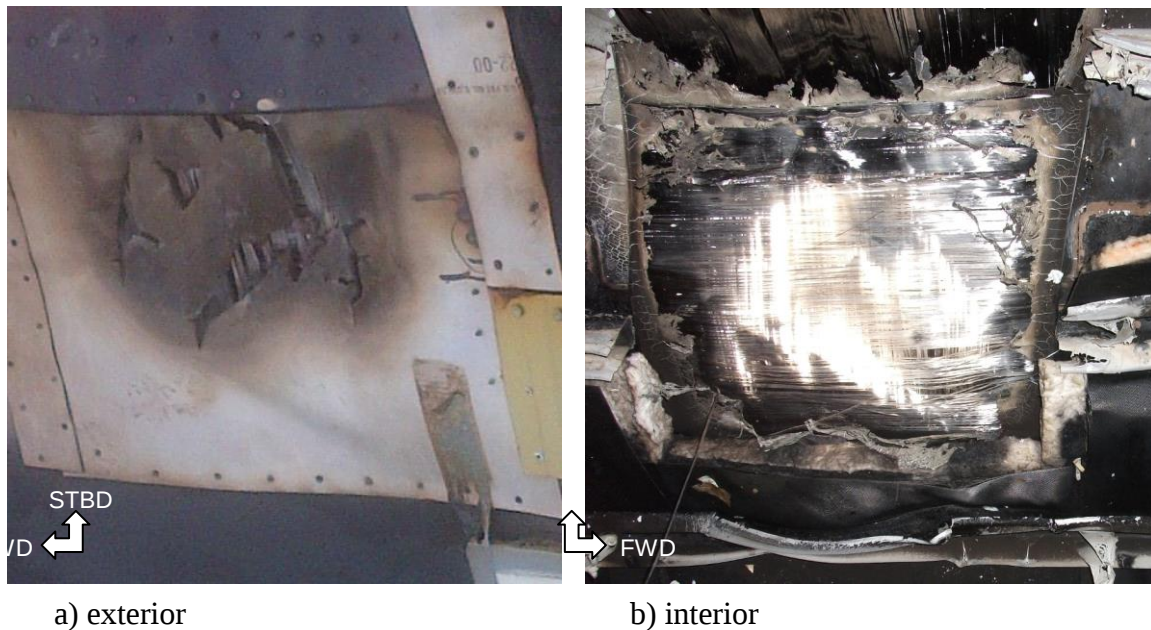
Figure 30. Burn through on panel 3B1.

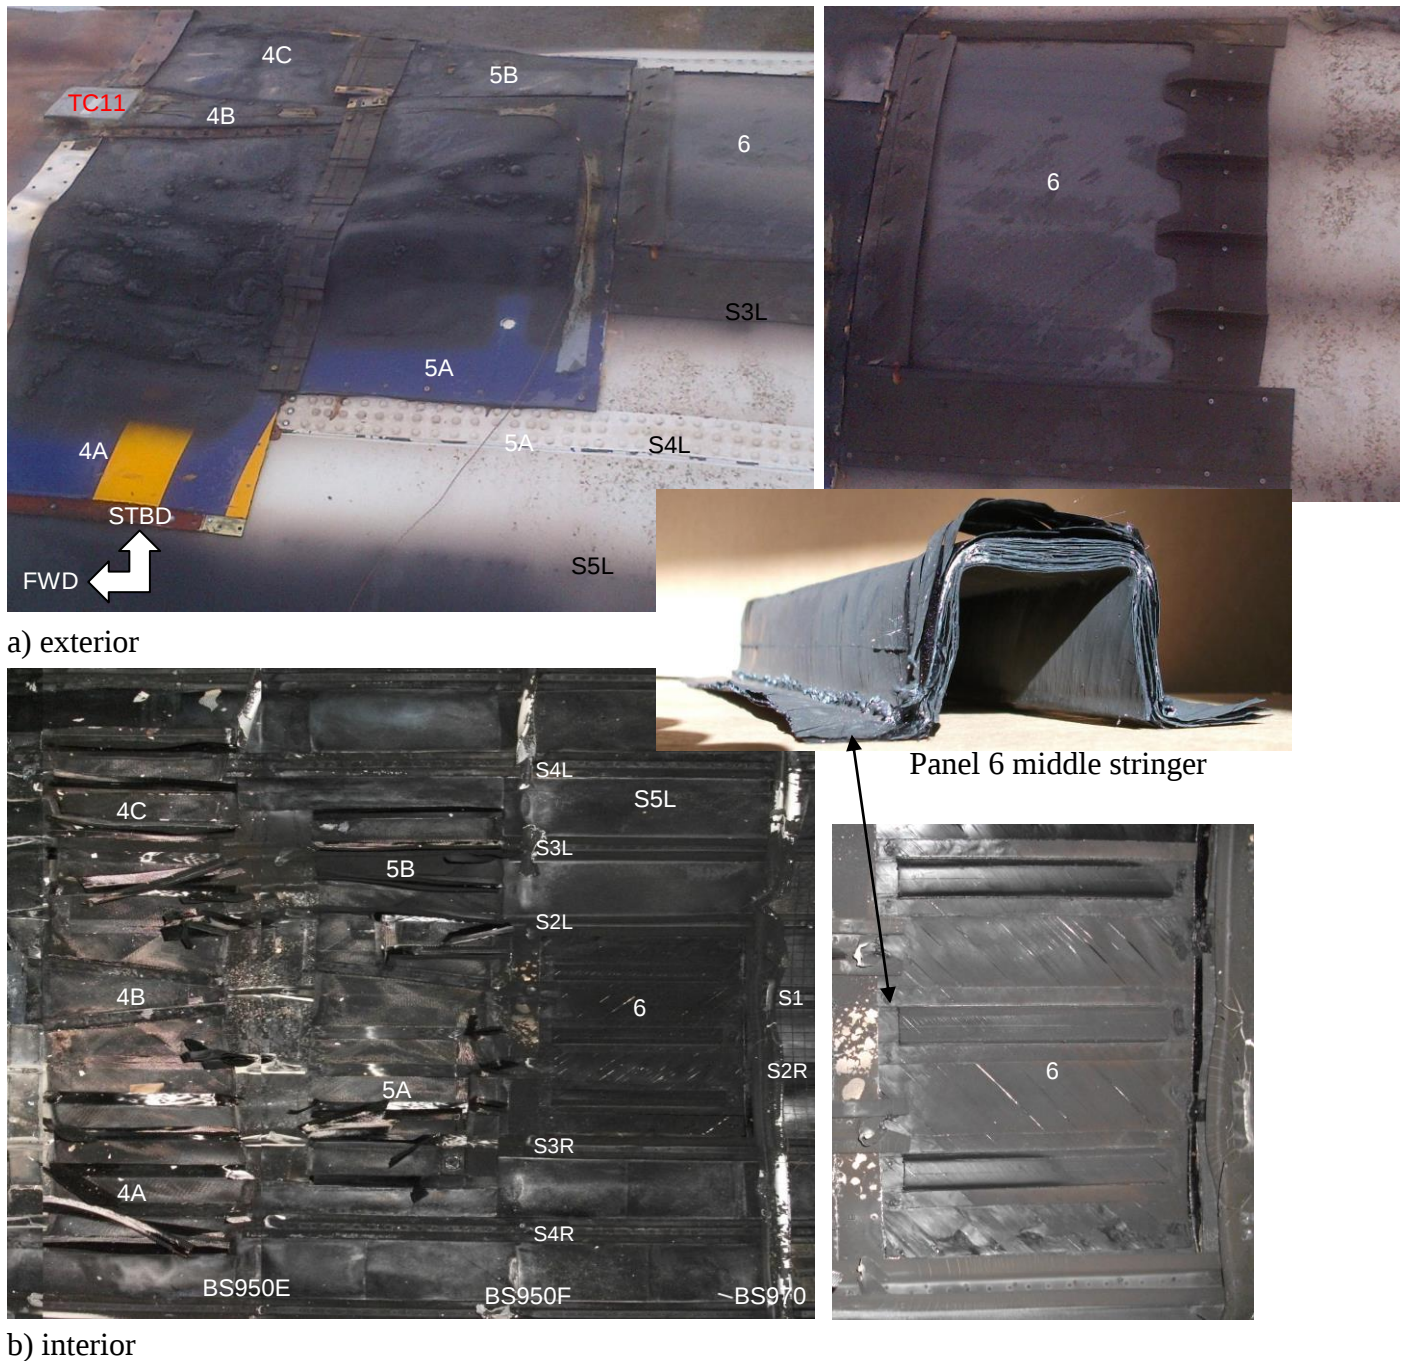
Figure 32. CFRP panels 4, 5 &amp; 6 (with close-ups).

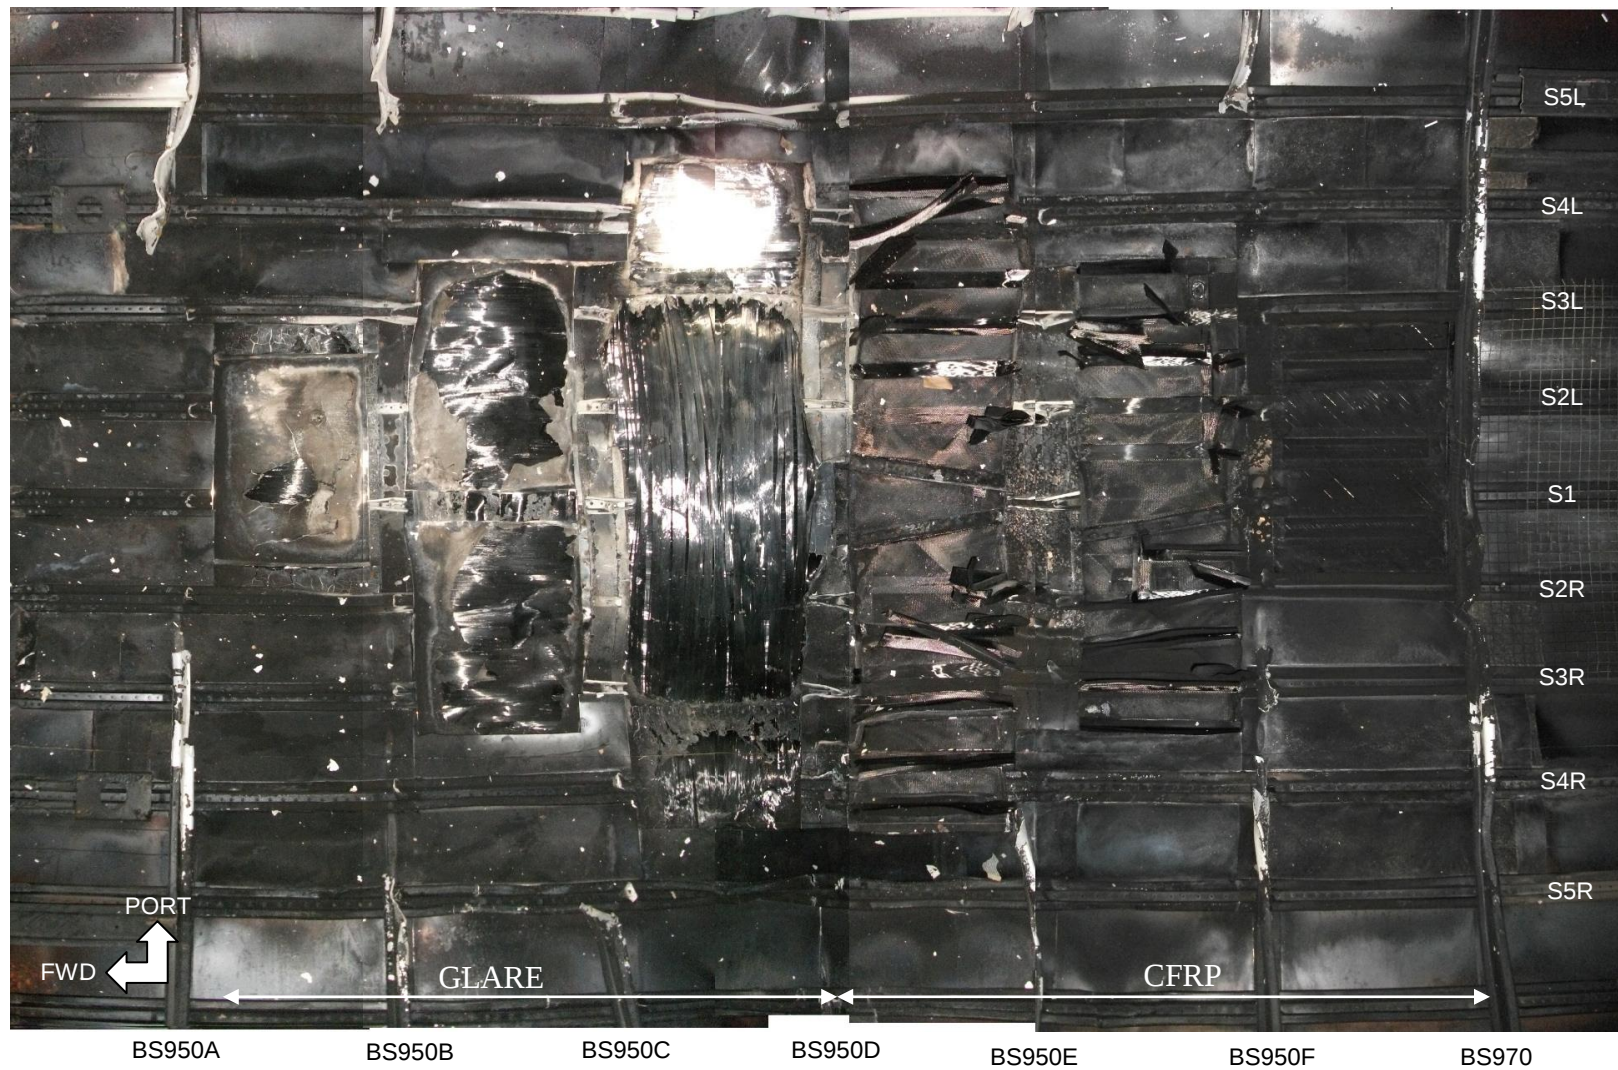
Figure 33. Test 2 fuselage crown, post-test damage.

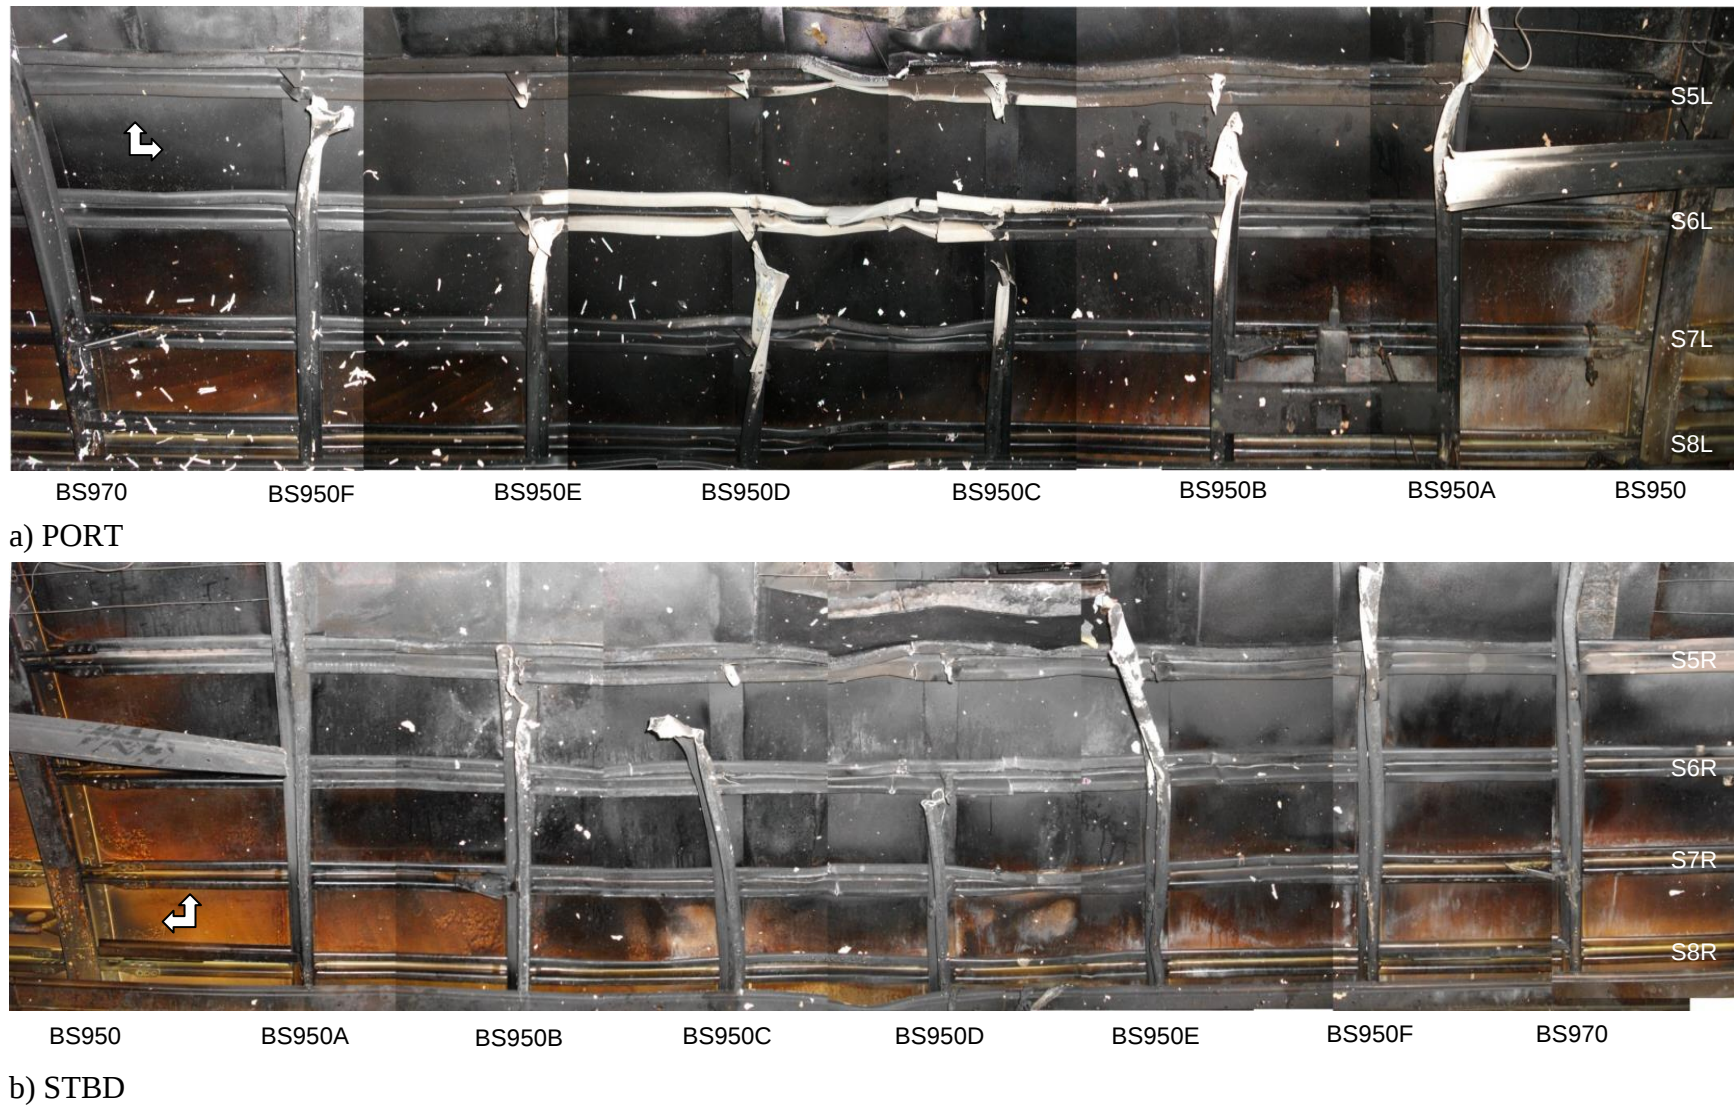
Figure 34. Test 2 fuselage sidewalls, post-test damage.

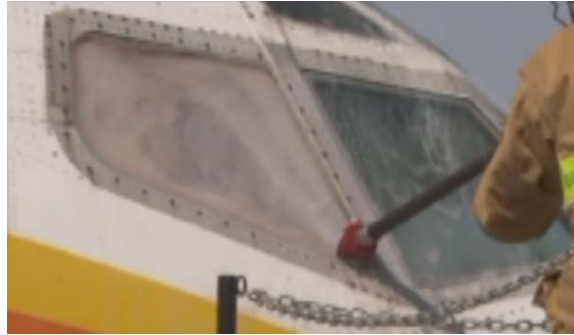
c) Quit without full penetration at 10:47:04. Plies were delaminated and water filled cavity.

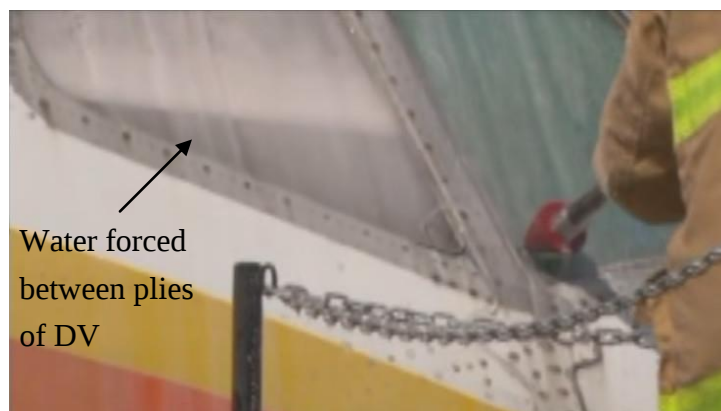
c) End at 10:47:43. Window was fully penetrated.

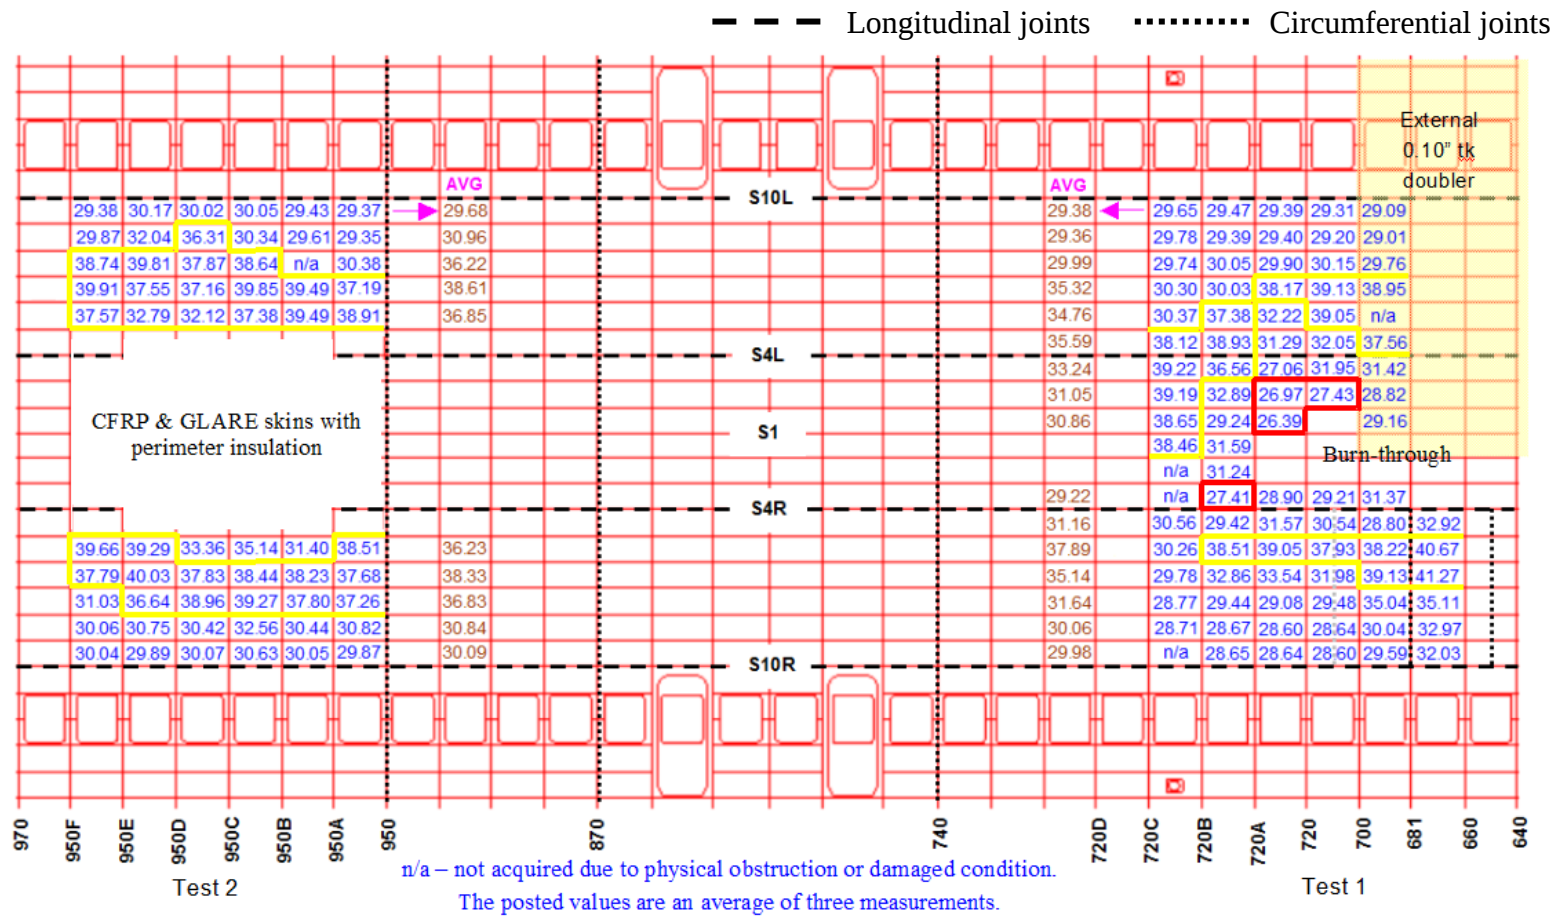
Fig. A.IV-1 Post-test 2024-T3 aluminium skin conductivity (% ICAS) measurements and average values (horizontally).

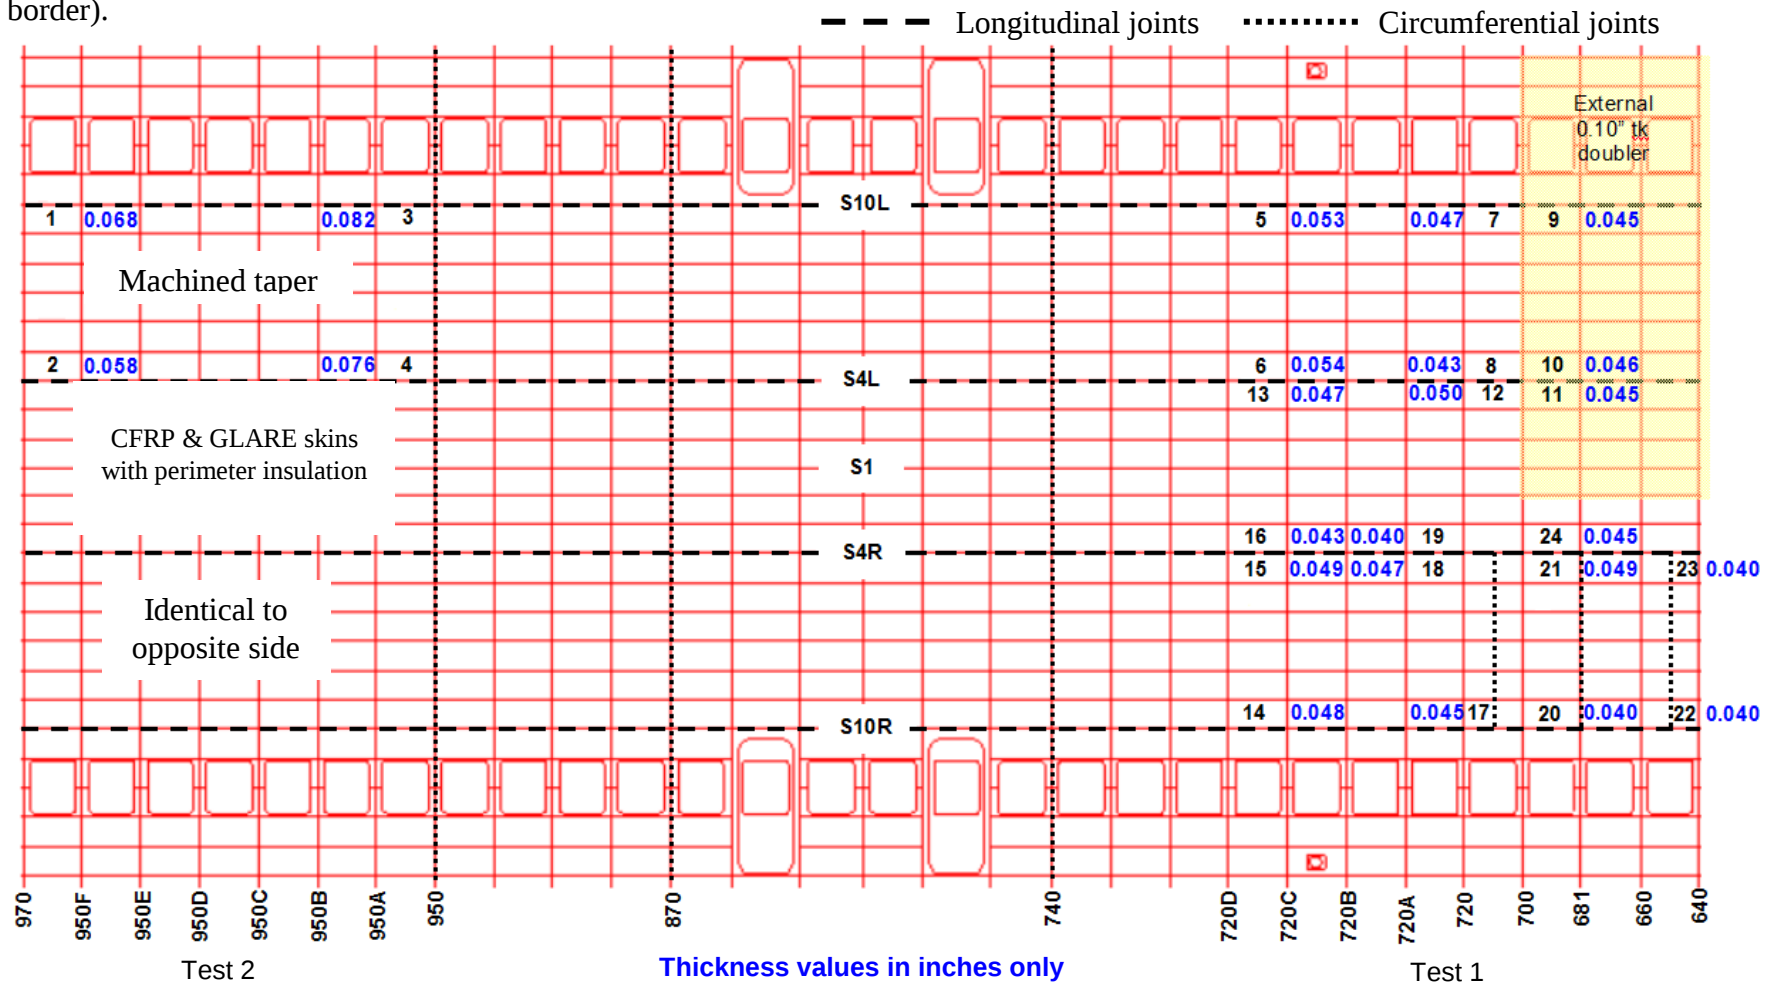
Fig. A.IV-2. Post-test aluminium skin sample locations (black) and skin thickness (blue).
