AEROSPACE – GROUP  
NATIONAL RESEARCH COUNCIL CANADA

## **Full-Scale Aircraft Fire Tests - A Comparison of Aluminium and Composite Burn-Through**

Report No: LTR-SMM-2015-0414

Date: May 2015

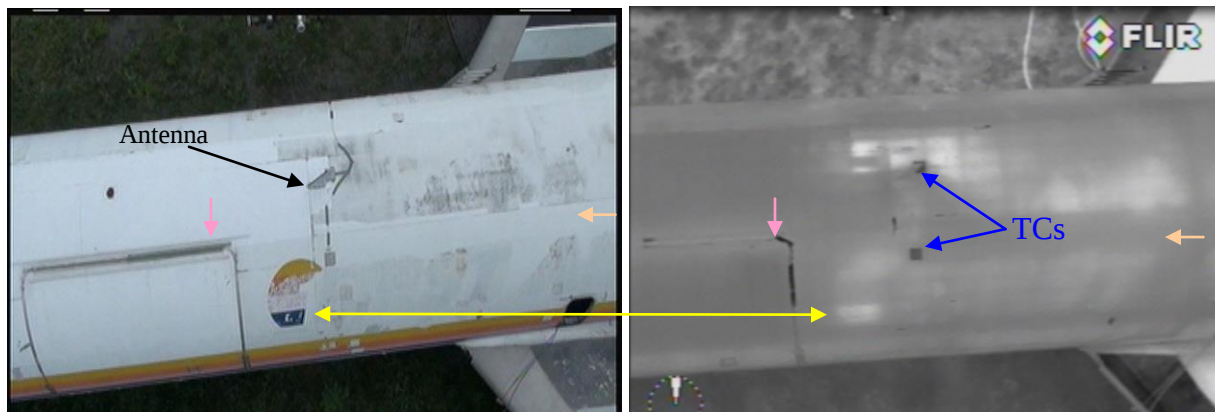
a) Video and Thermal camera images of fuselage crown prior to test. Note solar heating and differences in paint and metal tape emissivity (arrows). TCs #11 & #12 were each covered by a ceramic insulation block held in place with duct tape which are more noticeable in the TIC view.

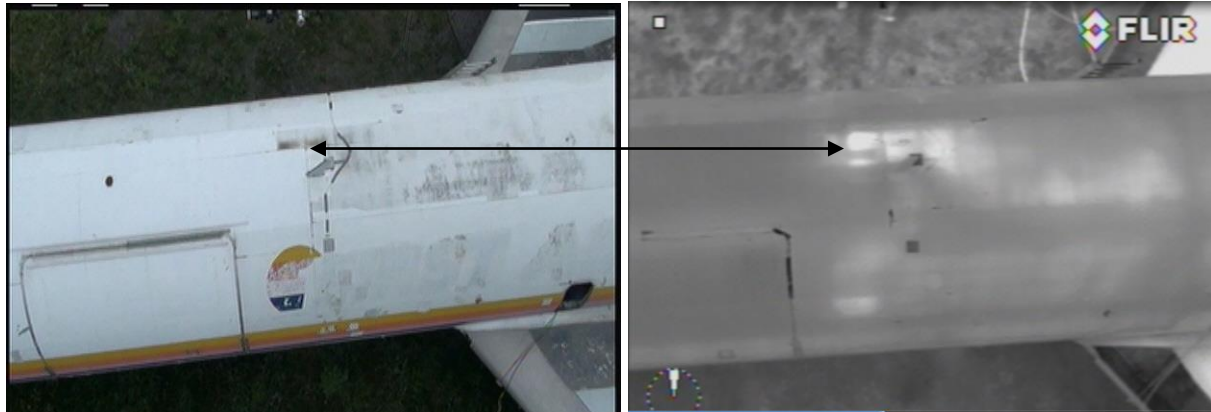
b) First exterior indication of fire (arrow) is in the region of solar heating.

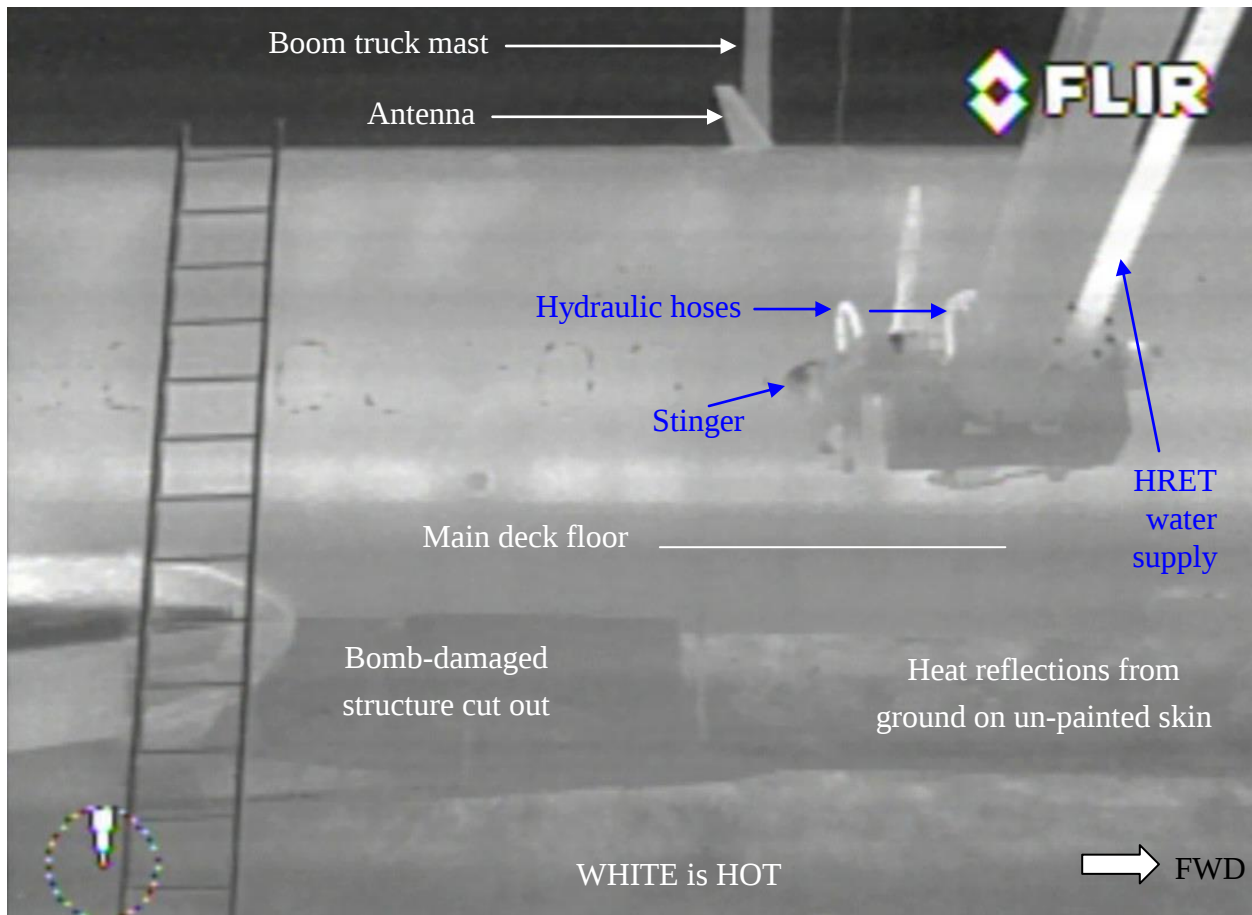
Figure 17. Red 10 TIC side-view of STBD side prior to Test 1.

The HRET fire truck TIC camera side-view is shown in Figure 17 before the fire. The Stinger hydraulic hoses and black-painted HRET water supply pipe appear white but they are not hot. The cause is the different in surface emissivity.

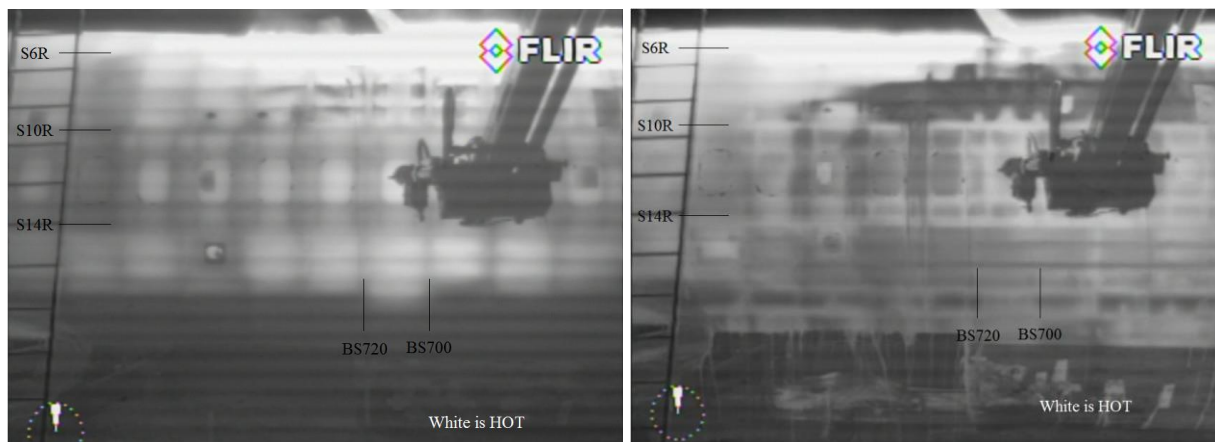
Figure 18. Red 10 TIC views at the beginning and end of the first Stinger extinguishment.

The following stills, Figure 18, from the Red 10 TIC video are noisy with interference lines scrolling vertically that affect the still images making it difficult to discern the substructure. Live or when the video is re-played, this interference is less pronounced.

The first extinguishment with the HRET Stinger at 6:57 affected the outer skin of the aircraft as shown in the Red 10 TIC views, Figure 18. By the end of the extinguishment (7:55) water has cooled an area from just above S8R and down to the main deck floor. Heated water can be seen draining from the aircraft. The area cooled by the Stinger will be discussed further in Test 2.

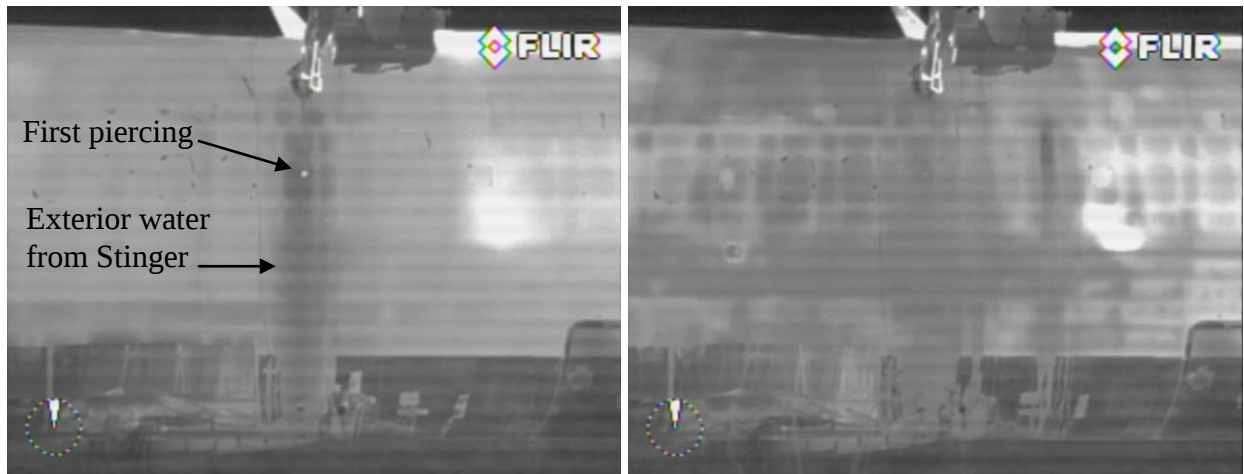
Figure 19. Red 10 TIC views just before and after second Stinger extinguishment.

The second HRET Stinger application at 16:27 was higher on the fuselage side and lasted for 57 seconds, Figure 19. A larger area was seen to be cooled but note that a hot spot remains.

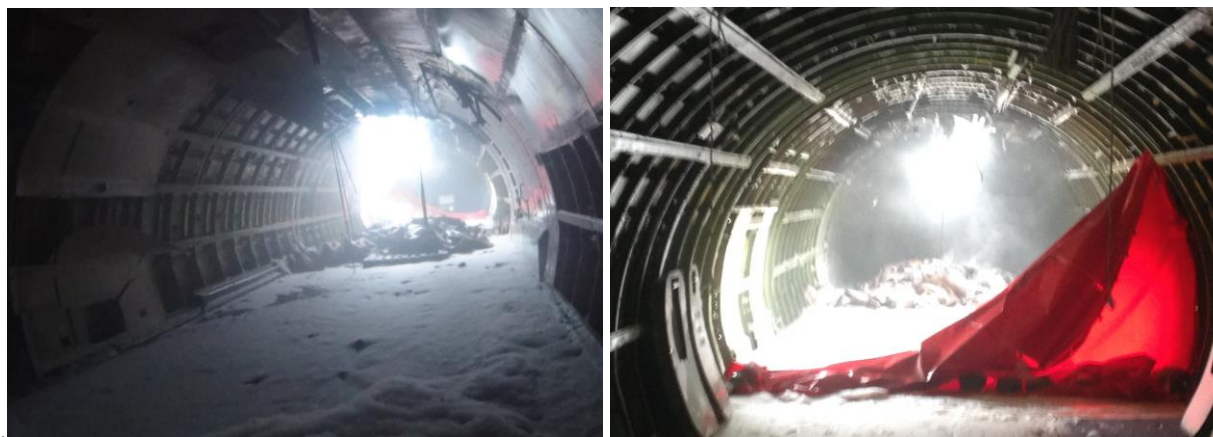
Figure 21. Post-Test 1 overhaul. Foam and remains of fuel load.

Images of the main deck after the CAFS applications, second Stinger and hand-line work show a blanket of foam remaining and the un-burnt pile of boxes which was reported to be 18-inches deep (45.7 cm) when firefighters entered the zone, Figure 21.

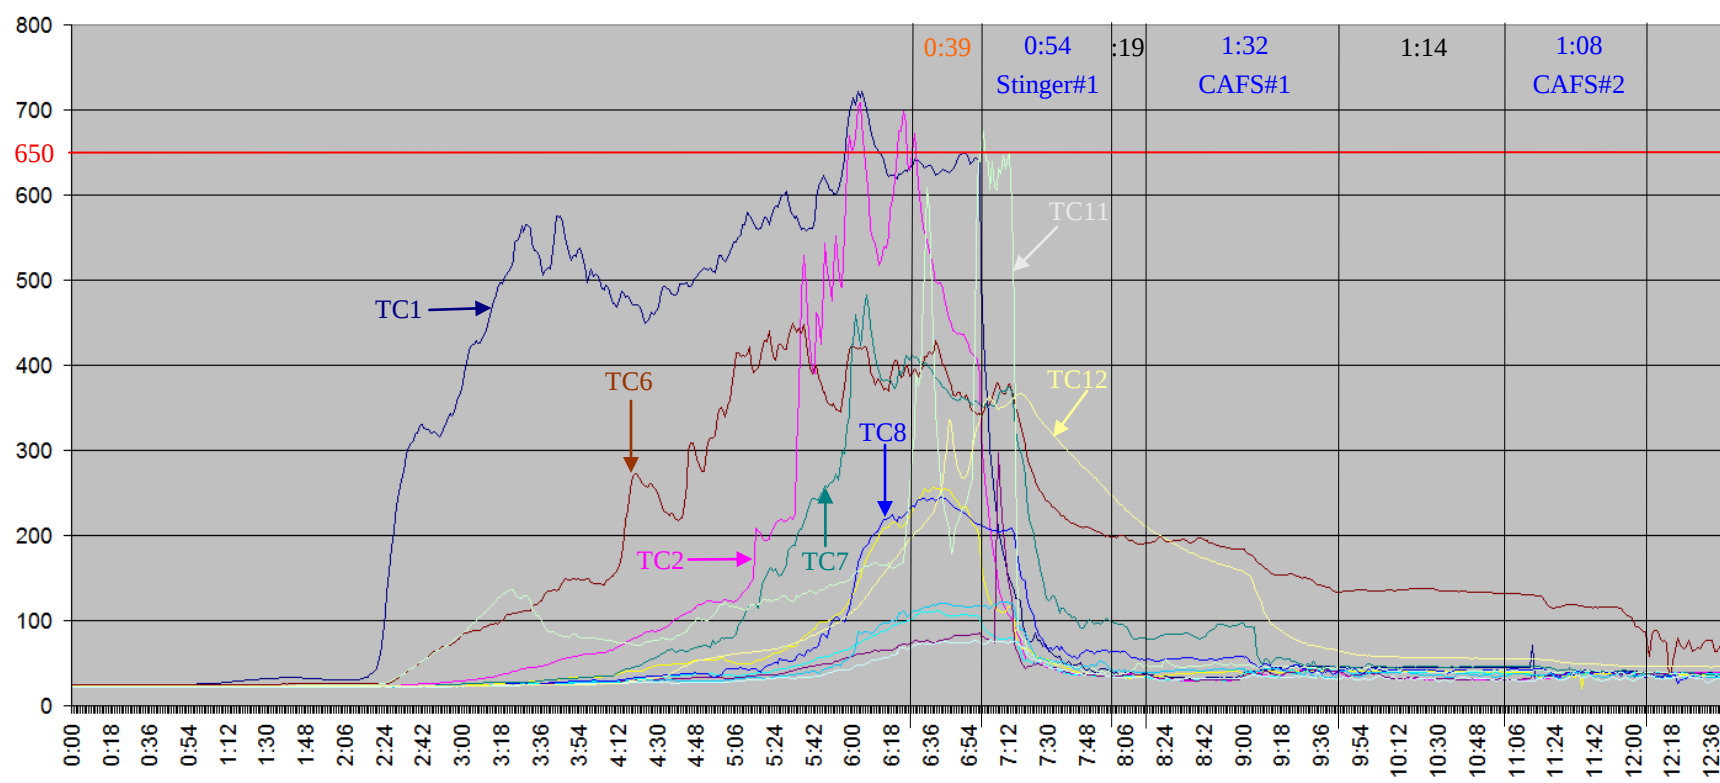
Figure 22. Thermocouple data (°C) for Test 1 with initial extinguishments annotated.

The temperature data from the 12 TCs were collected at one second intervals. The data for Test 1 is presented graphically in Figure 22. Note that according to Matweb.com, the reported melting point of 2024 T3 aluminium ranges from 935-1180°F (502-638°C) and for 7075 T6 aluminium ranges from 890-1175°F (477-635°C).

Other than TC#1, all of the other upper level thermocouple readings declined between the start of the crown burn-through until the start of the first HRET Stinger extinguishment. TC#2 had the most rapid temperature decrease, dropping 570°F (300°C). TC#6, at the top of thermocouple tree #2 and 160 inches (4.6 m) away from the crown breach, dropped 188°F (87°C) in the same period. This is evidence of the heat released by vertical ventilation as a result of the crown burn-through. All of the temperature readings fall soon after the first Stinger extinguishment starts.

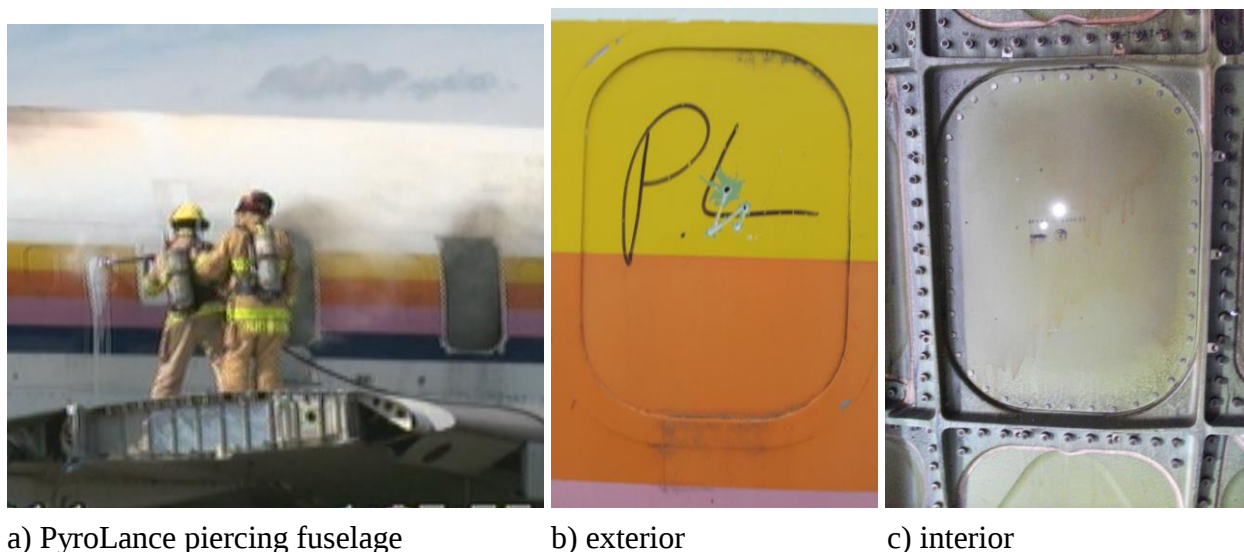
Figure 27. PyroLance piercing fuselage, Test 2.

The PyroLance piercing is shown in Figure 27 with a view after the fuselage has been pierced and while agent is being delivered inside the fuselage. The exterior and interior surfaces of the two-ply aluminium window blank are shown post-test. The upper and larger hole was the first piercing and agent flowed through this hole for 41 seconds. The exterior view also shows the track after the operator slipped and the operator triggered for abrasive media to try and pierce through again. The panel was pierced a second time at the very end of the action but no significant amount of agent was delivered through this hole.

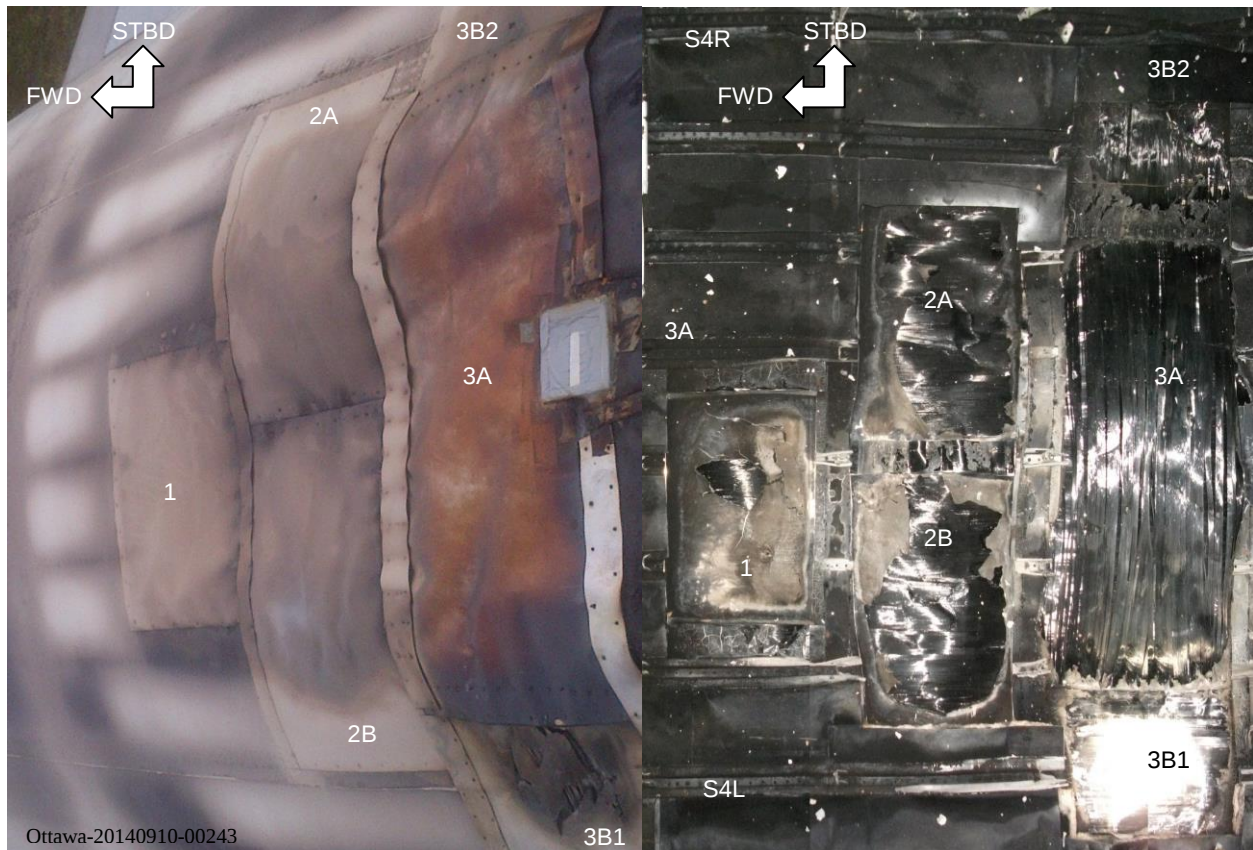
Internal inspection of the GLARE panels, Figure 29, revealed that all of them had suffered disassociation (delamination) of the layers and loss of some or all of the inner aluminium sheets as well as the epoxy adhesive. In effect, only the outer aluminium sheets remained intact except for panels 3B1 and B2 which both suffered some degree of burn-through. The burn-through area (breach of the outer aluminium ply) was largest on Panel 3B1. Smoke was observed escaping the fuselage from these breaches.

The GLARE panels would have normally been attached to aluminium stringers. As seen in Test 1, the stringers would have burned away or been damaged. The fibres seen hanging loose, such as those of panel 3A in Figure 29b, would be the realistic result of fire damage for this type of construction. A closer view of the burn-through to panel 3B1 is shown in Figure 30. The inner sheet of aluminium has melted or burned away with material remaining only around the perimeter where it was attached to other structure. The outer aluminium sheet had just been breached by the end of the test and the fibres within can be seen in these areas. The glass fibres remain in place and act as a restriction to the escape of smoke and heat.

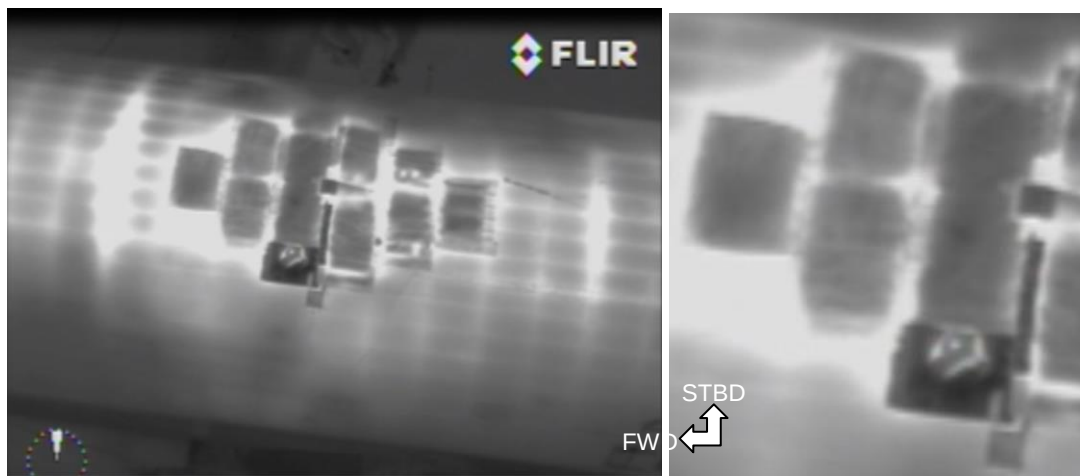
Figure 31. Overhead TIC image at 11:44 (after Stinger and PyroLance extinguishments).

Figure 31 shows an overall view from the overhead TIC camera after burn-through as well as a close-up of the GLARE panels. The camera setting was “white is hot”. Panel 3B1 was not painted white and the emissivity of its outer surface caused this panel to show as black throughout the test. The heat escaping through the breach in panel 3B1 is being detected as hotter (white) as can be seen in the images.

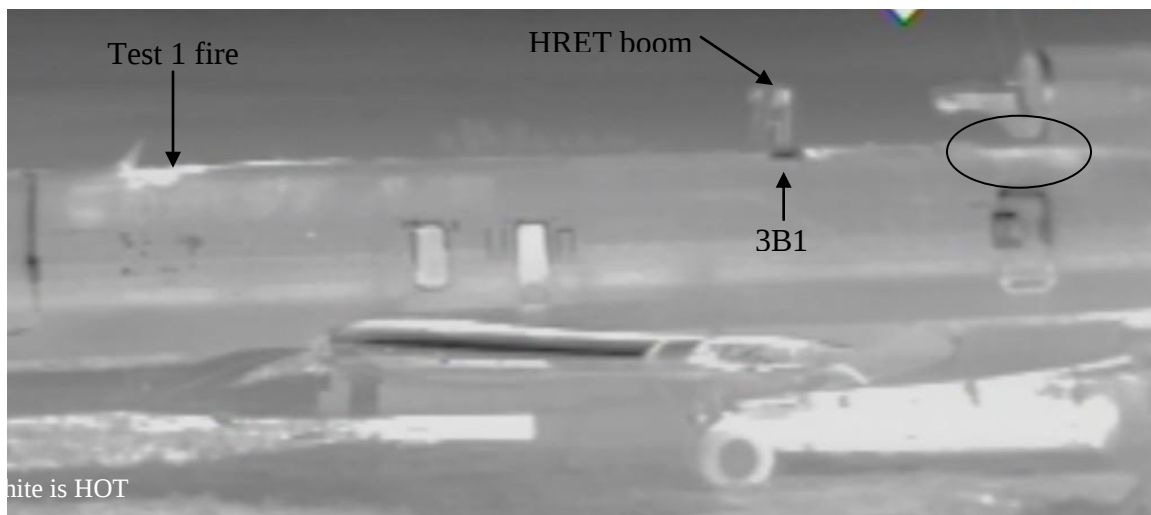
Figure 35. Prior to Test 2 fire start the Red 9 TIC side view shows panel 3B1 as 'black'.

With reference to the Red 9 TIC side-view in Figure 35: it can be assumed that solar heating has raised the temperature of the blackened skin around the Test 1 fire site. In both the overhead and side TIC camera views the exterior surface of GLARE panel 3B1 reports as black. Panels 3A and 3B1 were in the as-received condition with only a primer coating yet 3A did not report as black. All other GLARE panels were painted white. The source of the white (hotter) area just aft of 3B1 is unknown. It is interesting that the dark blue paint system on panels 4 and 5 and the unpainted black CFRP panel 6 are not being reported as hotter (by solar heating) than the surrounding aluminium although the Red 9 TIC side-view of these panels is minimal. The crown skin area forward of the V Stab and between S4L&R (circled in Figure 36 and shown in Figure 37) is painted black which may account for the reported heating or it may be an emissivity difference. The overhead TIC view did not include the area AFT of BS1010.

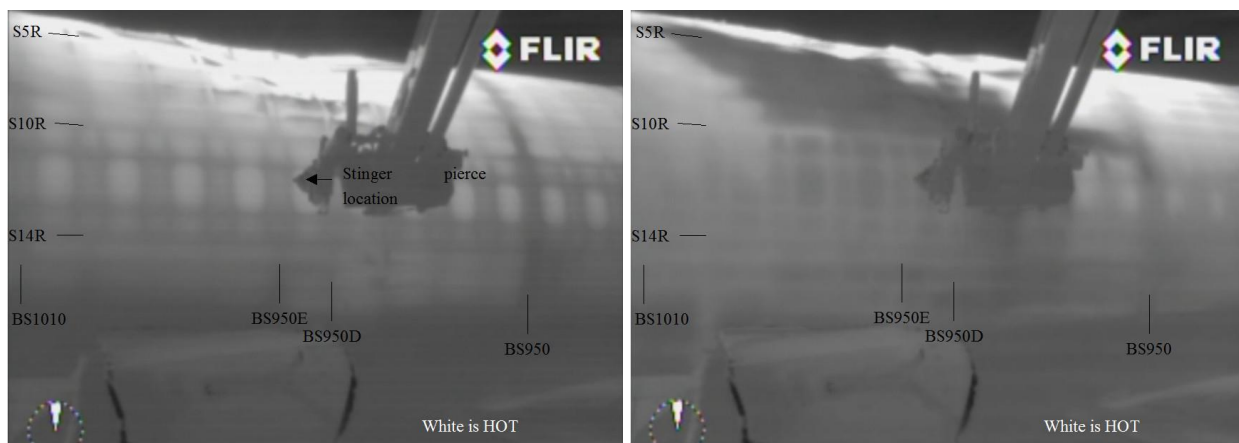
Figure 38. Extent of Stinger water spray cooling effect on STBD fuselage between 7:49 and 8:55.

The fibreglass cargo liner had been completely removed from the fuselage sidewall and as such there was no impediment to the water spray contacting the STBD fuselage skin and substructure. The piercing was carried out through the window blanking plate between BS950D and 950E. The maximum fuselage skin area cooled by the water spray is shown in Figure 38 and extends from BS950 to 1010 between S4 and S10R.

Based on the Red 10 TIC video stills in Figure 38 and the CAD sketch in Figure 40, the first water spray cooling is seen along S8R with a little impinging slightly above up to S5, (upper red and blue lines from Stinger in sketch). There isn't as definitive a cooling effect visible on the fuselage STBD side below the Stinger (reciprocal angle). By the end of the water spray event the cooling effect is seen to extend from S5R down to S10R. The cooling from S8R down to S10R is apparently not from direct spray but must be from gravity, otherwise water spray would also show from S14R down (Yellow lines in sketch) but it doesn't. No cooling was visible on the PORT side, Figure 41.

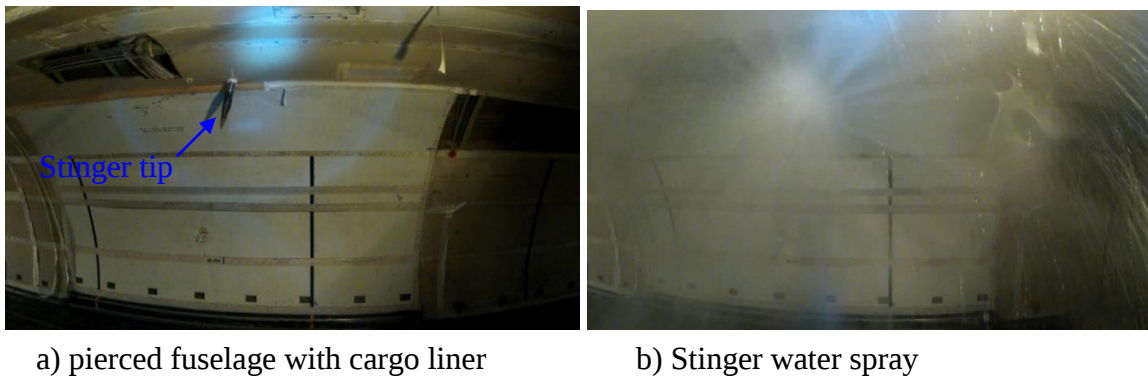
Figure 39. Example of unobstructed chisel-type Stinger tip water spray pattern.

Figure 39, from LTR-SMPL-2012-0126, shows the water spray pattern of the chisel-type Stinger tip is a fan shape with little water projected forward.

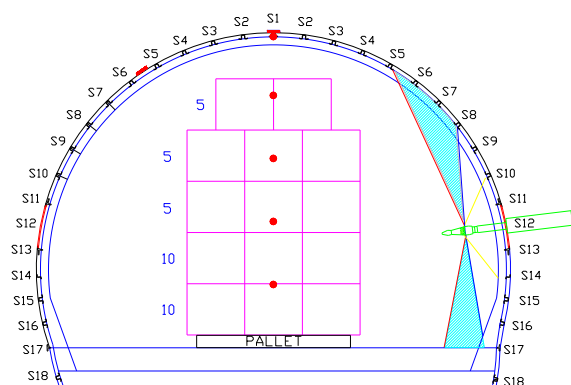
Figure 40. Water spray from Stinger.

There are 32 orifices in the piercing tip arranged in four rings of 8 each. The rear two rows are large and project water radially. The front two rows are small orifices that are angled forward. The water spray from the small, forward-projecting orifices are not shown in the sketch.

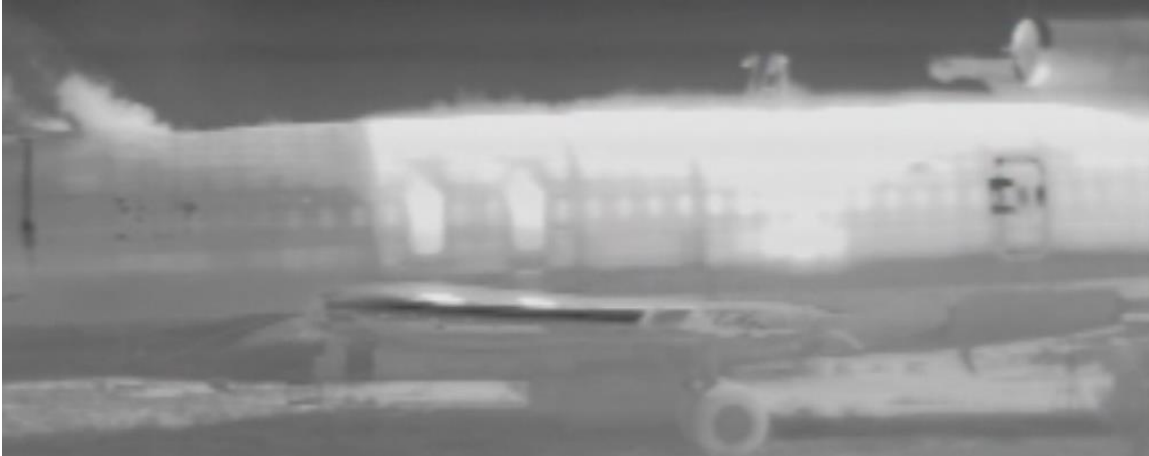
Figure 41. Red 9 TIC at 8:00. No Stinger water spray cooling on PORT fuselage skin.

The salvage tarp failed at 7:45. The Stinger pierced at 7:40 and water flowed from 7:49 to 8:55 (1:06 duration). Figure 41 shows that the water does not cross the fuselage and cool the opposite sidewall. This is because some portion of the fuel package may still be in-between and the flat-fan spray pattern of the chisel-style tip does not project very much water forward.

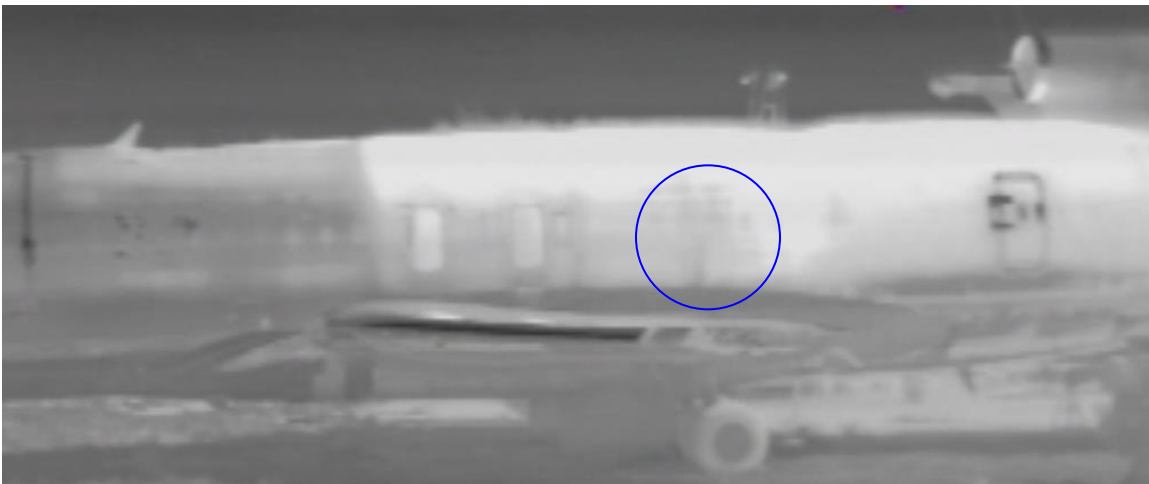
Figure 42. Red 9 TIC at 10:00. Evidence of PyroLance cooling PORT fuselage skin (circled).

As shown in Figure 42 and Figure 43, the water spray cooling effect of both the PyroLance and hand-line extinguishments could be witnessed by observing the Red 9 TIC side-view of the PORT side. The effect of water impinging on the PORT fuselage skin from the PyroLance being operated from the STBD side was observed to cool the PORT side, circled in Figure 42, starting at 9:27 and persisted throughout the 1:06 application. The cooled fuselage area caused by the initial hand-line water spray is circled in Figure 43.

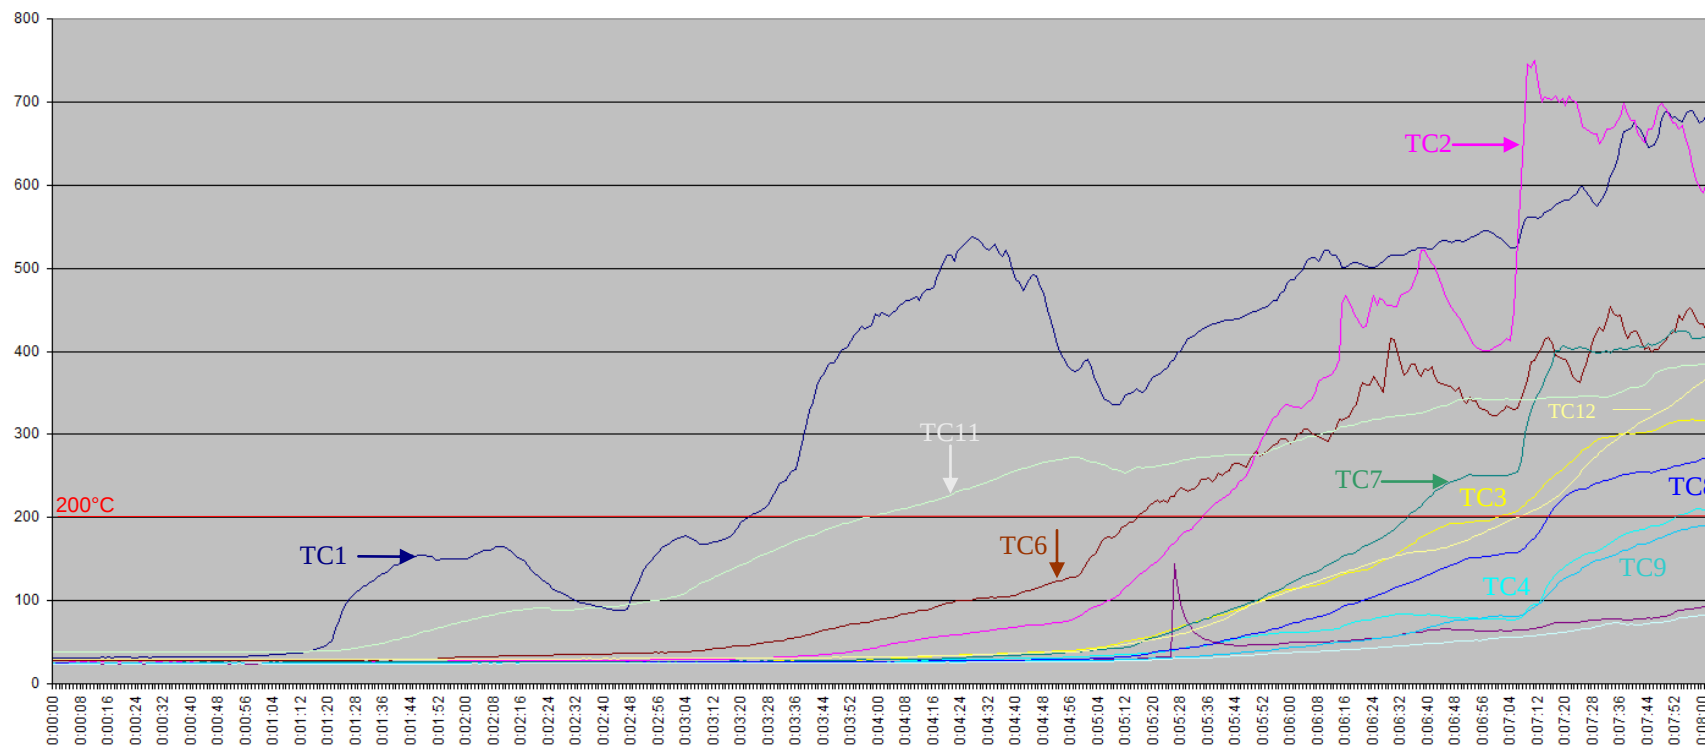
Figure 44. Test 2 fire temperatures (°C) prior to extinguishments.

The temperature data collected during Test 2 are shown graphically in Figure 44 and Figure 45. The first shows the temperatures recorded from the beginning of the fire. The second shows the period with the initial extinguishments and intervals between annotated.

As evidenced by the TC#1 data the fire suffered two periods where the fire dampened. This is mirrored to a lesser extent in the TC#11 data. In both cases re-ignition could be seen as a flash through the smoke in the forward-looking interior camera views. TC#2 exceeded 650°C (1202°F) approximately 28 seconds before TC#1.

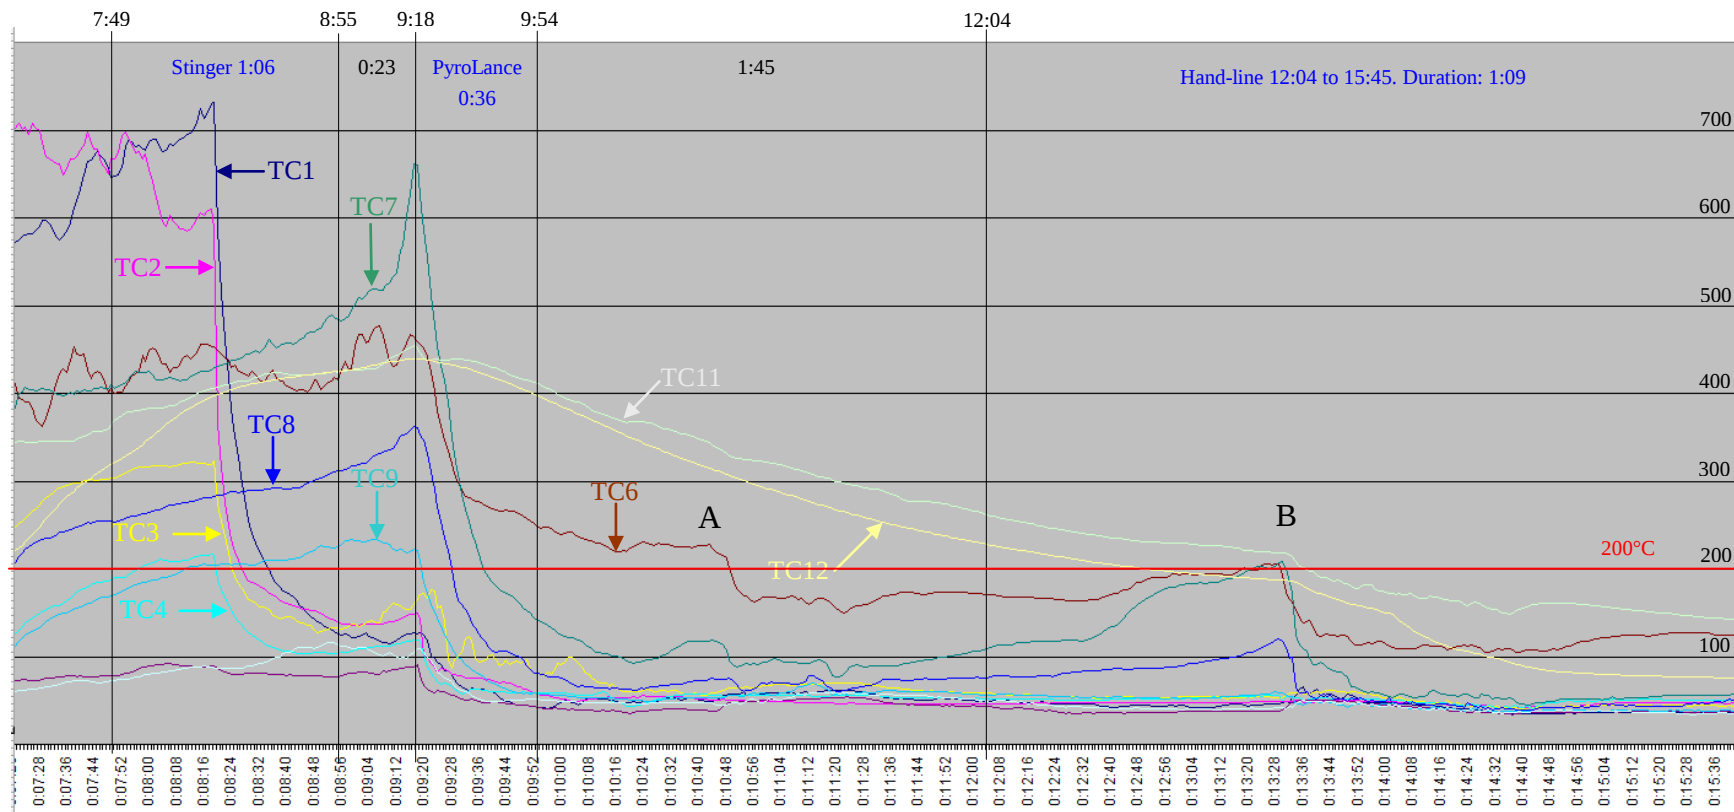
Figure 45. Test 2 temperature data during initial fire extinguishments.

In Figure 45 the period of the Stinger, PyroLance and over-wing hand-line extinguishments have been marked by vertical lines with the duration of the water sprays and intervals between marked. The Stinger spray was centred on the fuel stack and did not appear to cool above S8R. Its effect was initially between the STBD fuselage sidewall and the fire and had little immediate effect on the two thermocouple trees but it did eventually cause the thermocouple tree #1 temperatures to drop (TC#1 through #4). TC#6 was also affected but TCs 7 through 9 of thermocouple tree #2 continued to rise until the PyroLance was applied. The PyroLance spray likely passed between the two thermocouple trees based on the position and angle it was operated at and almost all TCs show a drop caused by this extinguishment. The two exterior thermocouples slow their rise during the Stinger event and begin to decline during the PyroLance extinguishment but this is likely a cumulative effect as all of the interior thermocouples registered rapid declines in temperature at about the same time.

There is a sharp fall in the TC tree 2 temperatures measured by TC#6, 7 and 8 (marked 'A'). During the hand-line water spray event TC#6, 7 and 8 all see a temperature rise but they then all drop off similarly (marked 'B'). The audio record from inside the aircraft along with the external and internal video, have been scrutinized to confirm that no water spray events caused the temperature drops at "A". This temperature drop may be the result of the collapse of the fuel stack and, for "B", its disruption or direct water contact with the TCs by the hand-line water spray.

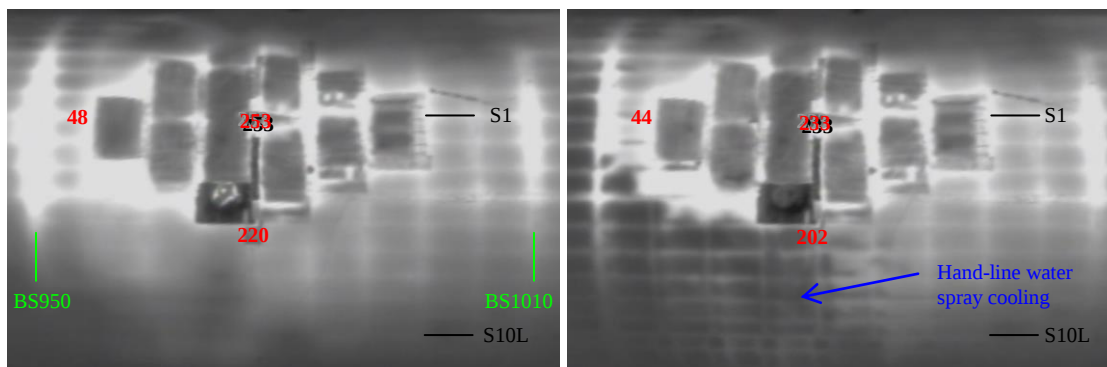
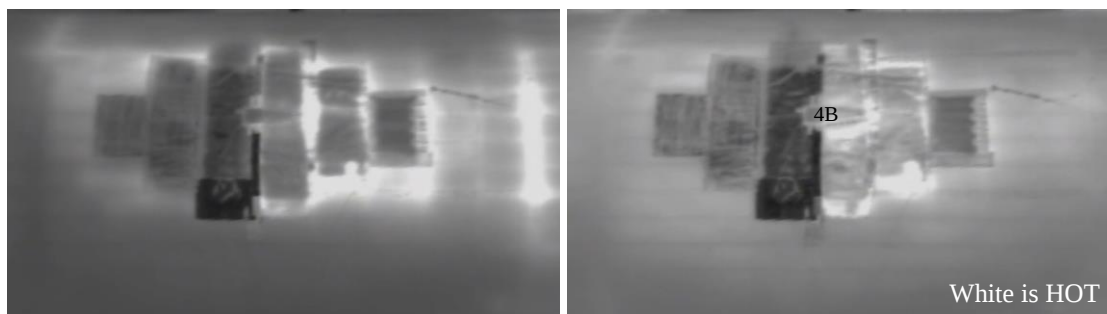
Figure 46. Selected overhead TIC views of composite skin panels from 11:44 to 27:44.

The overhead TIC video record of Test 2 started at 11:44 after the fire started. This is after the Stinger and PyroLance extinguishments and 20 seconds before the start of the STBD AFT over-wing hand-line attack (12:04) which lasted for 3:41 and ended at 15:45. Selected TIC video images are provided in Figure 46. Selected thermocouple data are provided in Table 2.

The thermocouple temperature recordings ended at 15:11, 34 seconds before the end of the hand-line attack. The firefighters were instructed not to apply water directly onto the composite panels in the crown. At 12:14 the effects of the initial water spray can be seen on the aluminium structure but this fades throughout the remaining attack indicating that water was being directed down onto the debris on the floor for the remainder of the extinguishment.

By 17:44 the heat has dissipated from the skin and the frame at BS950. Note that the frames at BS950 and 1010 are heavy forgings. Ten minutes later, at 27:44 the heat has almost completely dissipated at BS1010 yet the CFRP panels 4 & 5 remain hotter than their surroundings. It may be that where the CFRP panels are lapped over a second layer (CFRP or aluminium) they were protected from extinguishments and the decrease in cabin temperature and they continue to smoulder between the plies. This continued combustion of the adhesive is evidently heating the aluminium at the perimeter of the CFRP panels. Panel 4B is also hotter than its surroundings and this may also be evidence of heat from internal combustion emitting from the free edges of the panel.

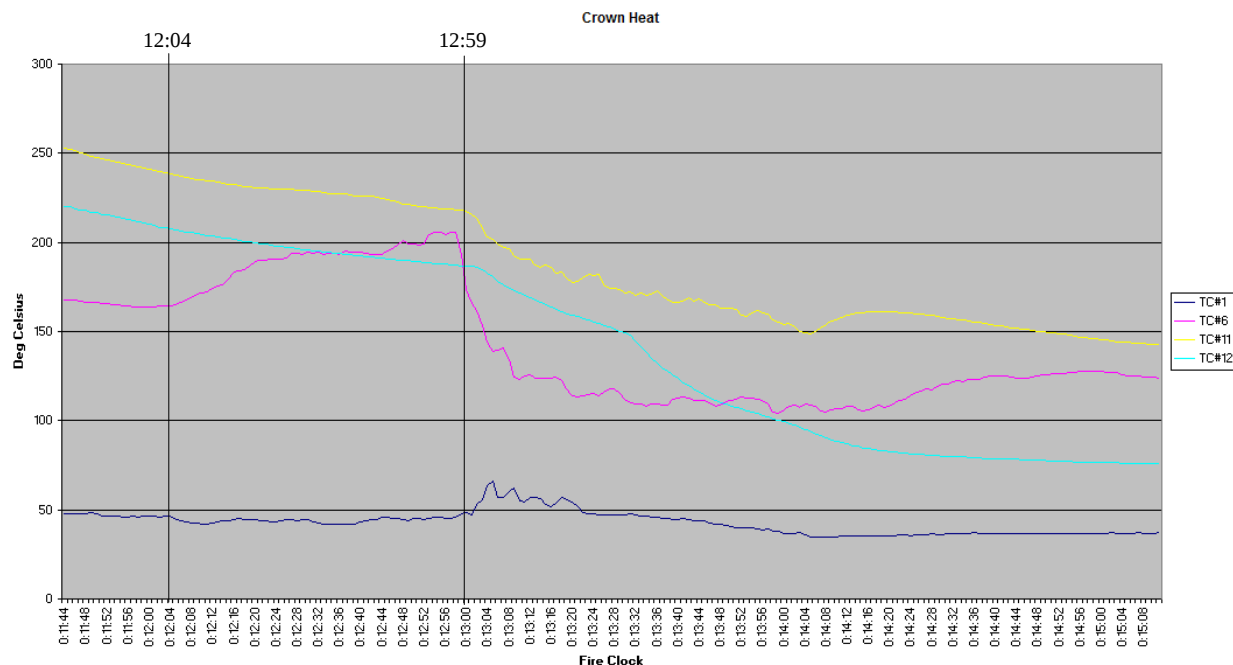
Figure 47. Crown (TC#1 &amp; 6) and exterior skin (TC#11 &amp; 12) temperatures.

Although the hand-line extinguishment starts at 12:04 the effect on the thermocouples is not seen to be an influence until 12:59 (Figure 47). TC#11 and #12 drop at the same rate initially but TC#11 levels off at around 300°F (150°C) while TC#12, on aluminium, decreases to level off just above 167°F (76°C). The persistent higher temperature recorded by TC#11 is most likely due to continued smouldering. TC#1 is hovering around 122°F (50°C) and then gets down to around 95°F (35°C). TC#6, far away at the top of thermocouple tree #2, sees a temperature rise during the extinguishment as heat is pushed away from the seat of the fire and up towards the crown.

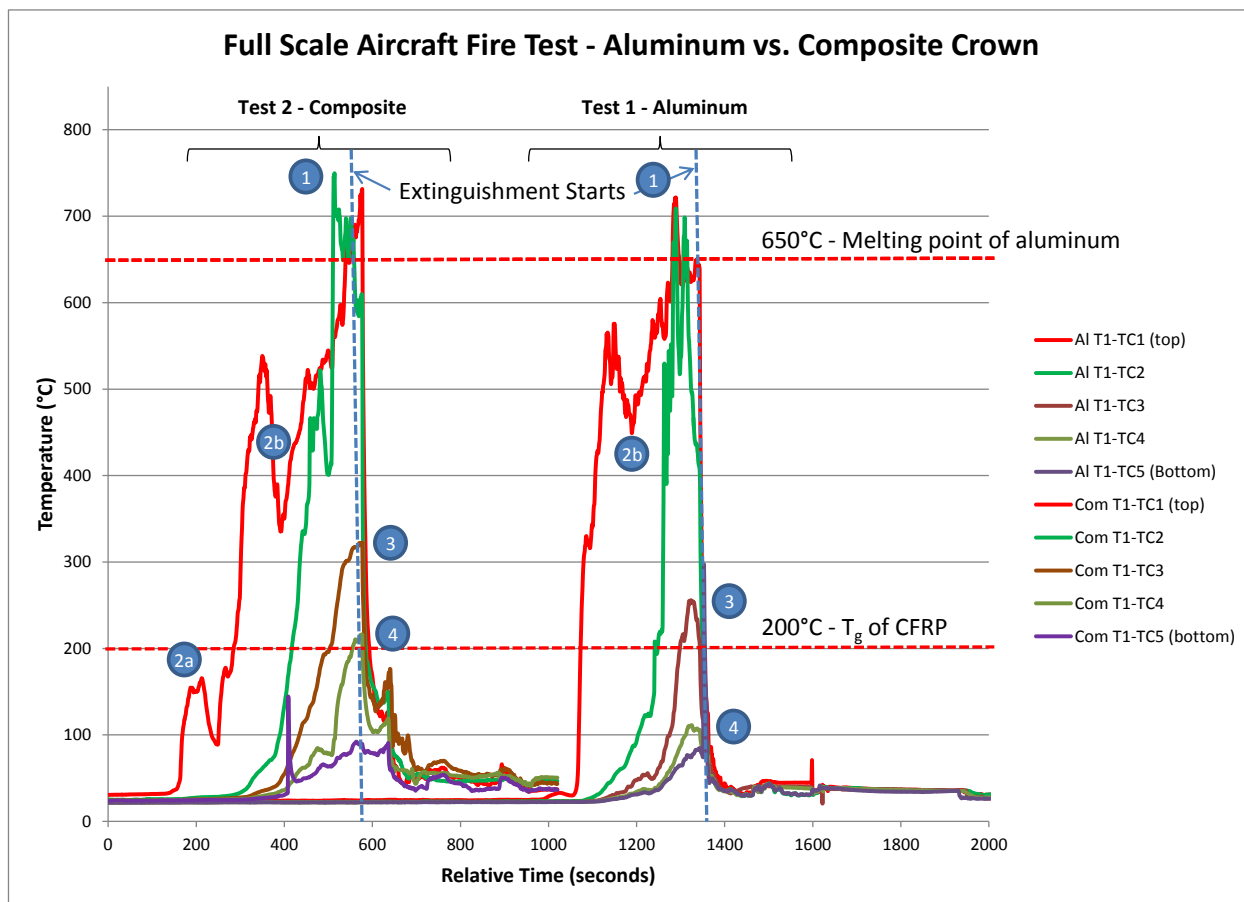
Figure 49. Test 1 versus Test 2 TC Tree 1 Temperatures.

Point 1: Test 1 and Test 2 were remarkably similar in their peak TC#1 temperatures of 1330°F and 1348°F respectively (721°C and 731°C). Also, both fires ran at temperatures over 750°F (400°C) in the upper half of the cabin for 4 minutes (Figure 49 and Figure 50). The composite fire (Test 2) was hotter for a longer period of time lower down in the cabin which may explain why a much larger area is heat damaged as evidenced by the blackened paint on the exterior.

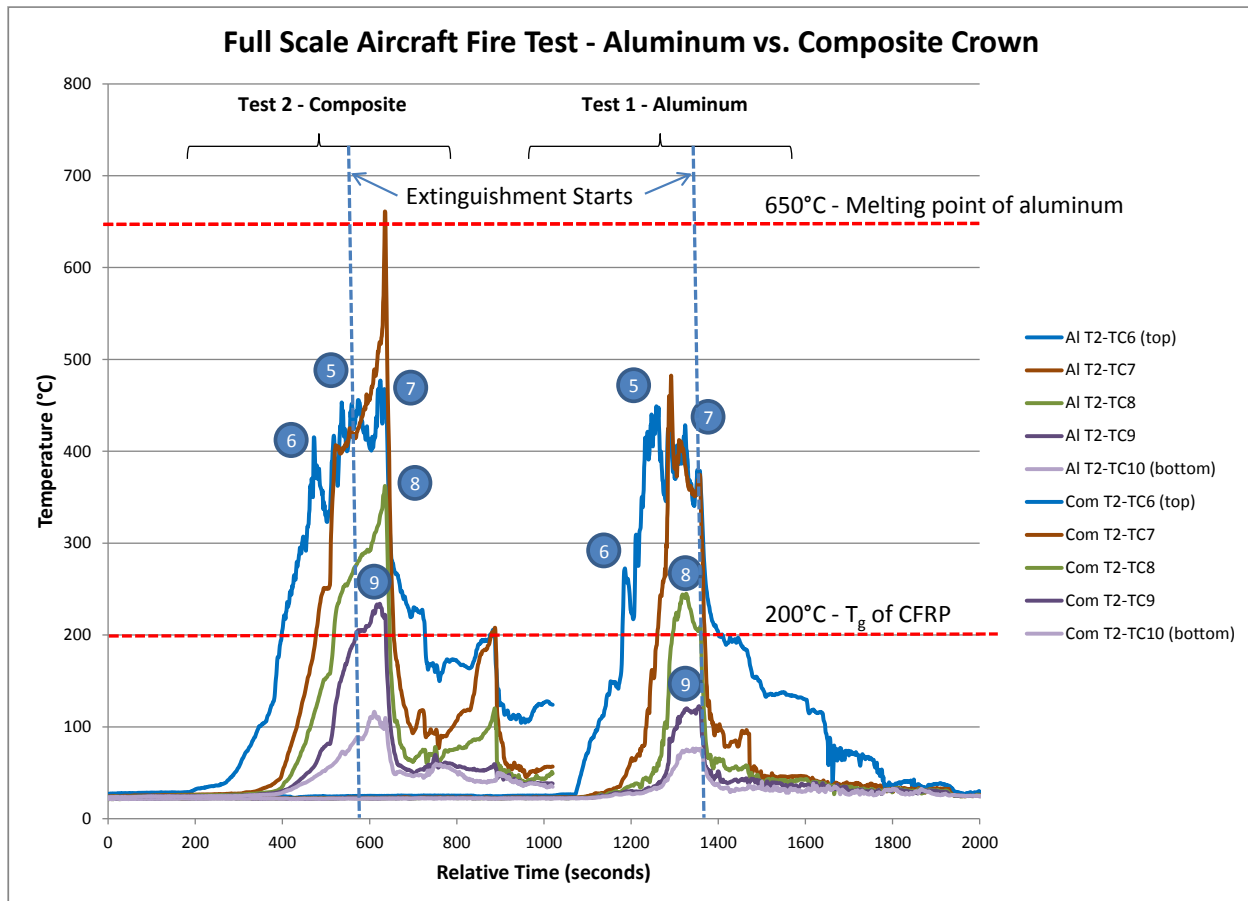
Figure 50. Test 1 versus Test 2 TC Tree 2 Temperatures.

TC#9 positions are further from the base of the fire and lower to the deck compared to the similar TC#3 and TC#4 comparison made previously. Again in Figure 50 the re-ignition of the Test 2 Composite fire is seen. No such secondary ignition is reported for the Test 1 Aluminium fire.

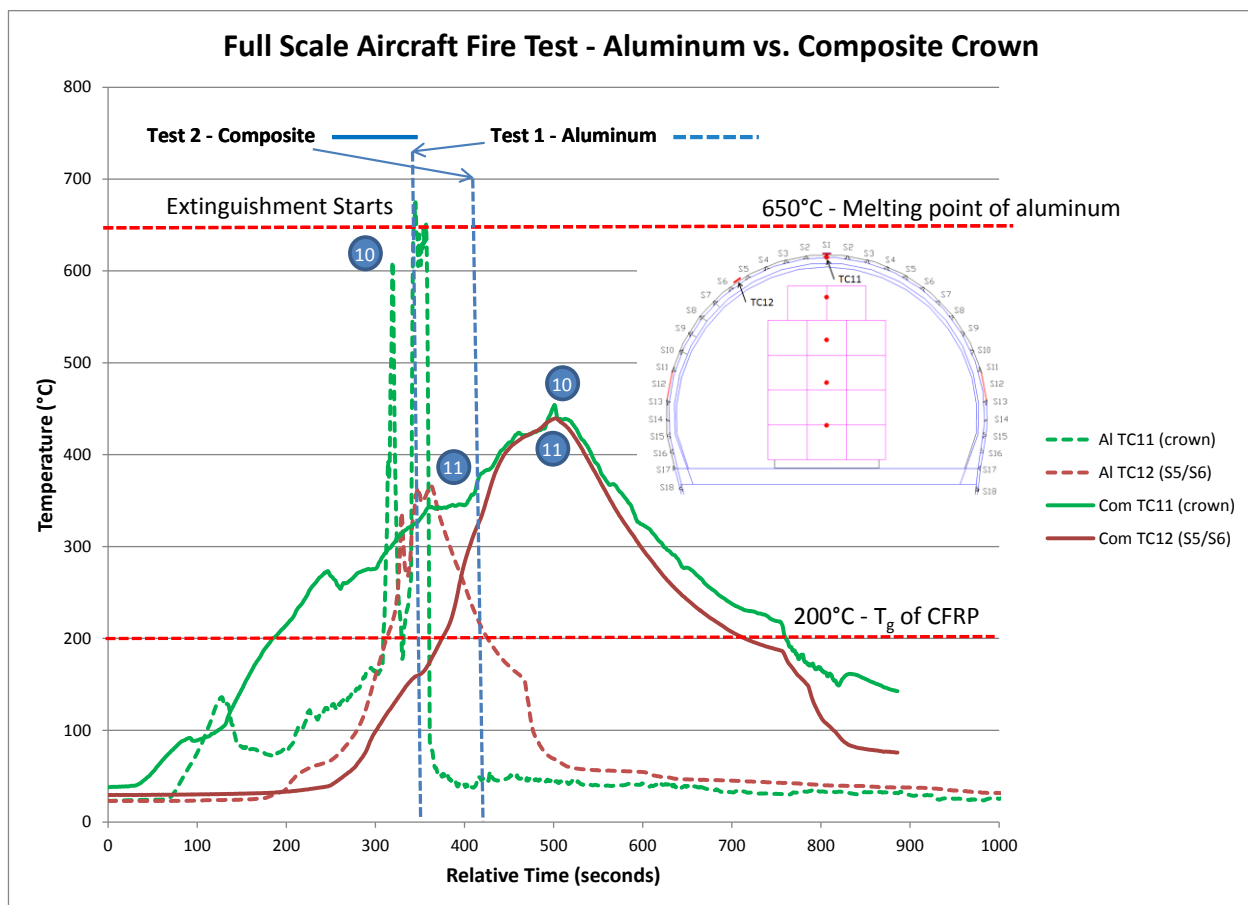
Figure 51. Test 1 versus Test 2 Exterior TC Measurements.

aluminium sheets melting away from the GLARE panels, they remained largely intact with respect to not allowing the Test 2 fire smoke and heat to vent. The fact that the aluminium sheets within the GLARE melted also indicates that the fire temperature was above the melting temperature of aluminium, approximately 1202°F (650°C).

Point 11: The much smaller difference between TC#11 and TC#12 for Test 2 compared to Test 1, almost zero compared to 441°F (245°C), respectively can most likely be attributed to the lower thermal conductivity of CFRP (approximately 0.87 Btu/hr·ft·°F (1.5 W/m°C) versus 69.3 Btu/hr·ft·°F (120 W/m°C) for aluminium) or could have been a result of the insulating properties of the burning laminate construction where the inner plies separated, creating separate insulating char layers.
