AEROSPACE – GROUP  
NATIONAL RESEARCH COUNCIL CANADA

## **Full-Scale Aircraft Fire Tests - A Comparison of Aluminium and Composite Burn-Through**

Report No: LTR-SMM-2015-0414

Date: May 2015

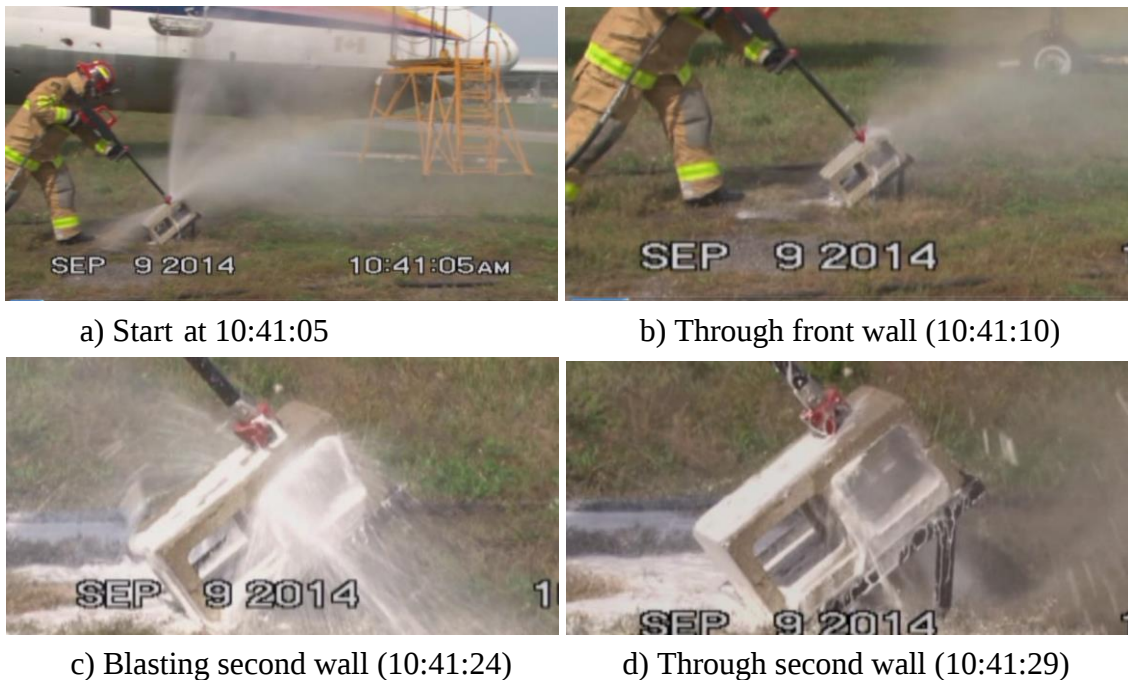
As there were many structural firefighters in attendance the first Pyrolance demonstration was against a concrete block. The water pump was operated at 1500 psi and granite particles constituted the abrasive media. The abrasive media is metered and introduced from a reservoir at the pump and then delivered to the piercing lance. With 150 feet of hose on the reel it takes approximately 30 seconds for the abrasive media to reach the tool after the trigger on the lance is pulled. There may have been some residual granite media in the system but this first application might be considered as being accomplished with minimal media in the high-pressure water jet. The application cut through the first wall of the block in five seconds and completely through the opposite side in another 19 seconds for a total time of 24 seconds (Fig. A.II-1.).

Fig. A.II-1. Concrete block. Water jet only. Duration:0:24.

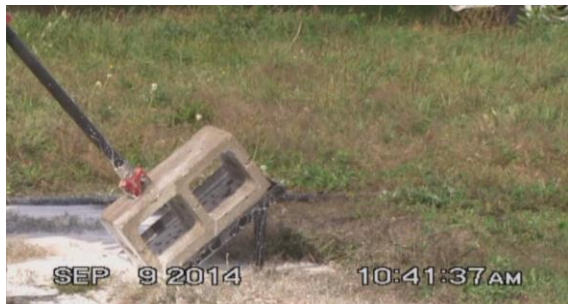
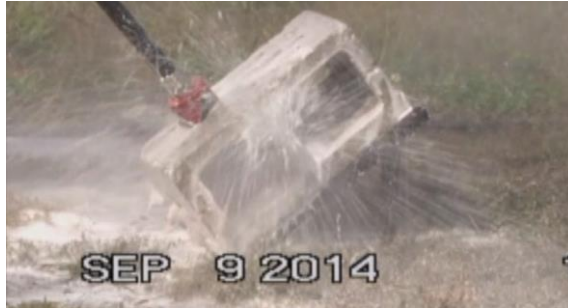
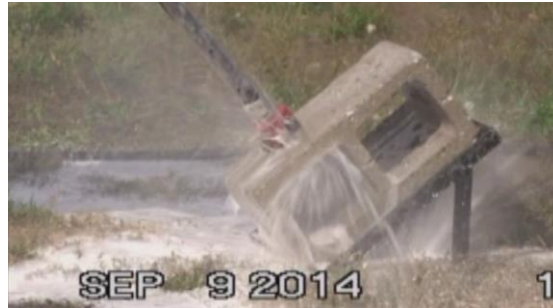
With abrasive media in the water flow for the second demonstration on the concrete block the jet pierced the first wall in one second and went completely through the block in nine seconds (Fig. A.II-2.).

Fig. A.II-2. Concrete block. Abrasive media &amp; water jet. Duration: 0:09.

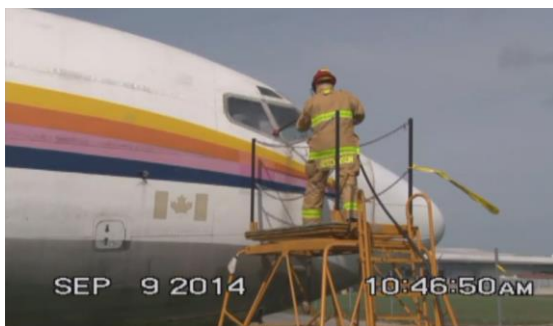
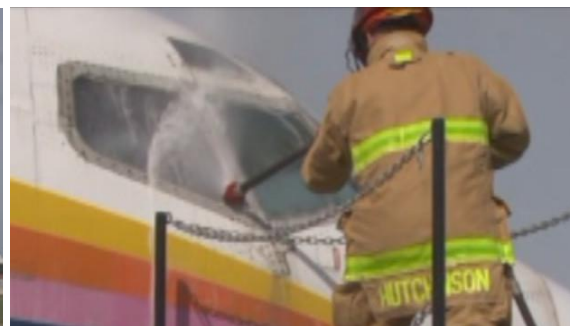
The next demonstration was on-aircraft against the cockpit windshields which are typically difficult to cut for emergency access to the cockpit. The Direct Vision (DV) side windows in this case are laminated stretched acrylic which is easy to cut with an abrasive disc or toothed circular saw blade. The PyroLance pierced through the outer layer but completely delaminated the plies such that water began to accumulate. This water layer absorbed the energy of the water jet abrasive media and delayed complete penetration. The trial was halted after 14 seconds (Fig. A.II-3.). The window might have been fully penetrated with a longer application as evidenced upon close examination from the inside (Fig. A.II-4). The water level was observed to be more than half the height of the window. The water was observed draining out during the second cockpit window trial.

c) Quit without full penetration at 10:47:04. Plies were delaminated and water filled cavity.

Fig. A.II-3. STBD DV cockpit window (laminated stretched acrylic). Duration: 0:14.

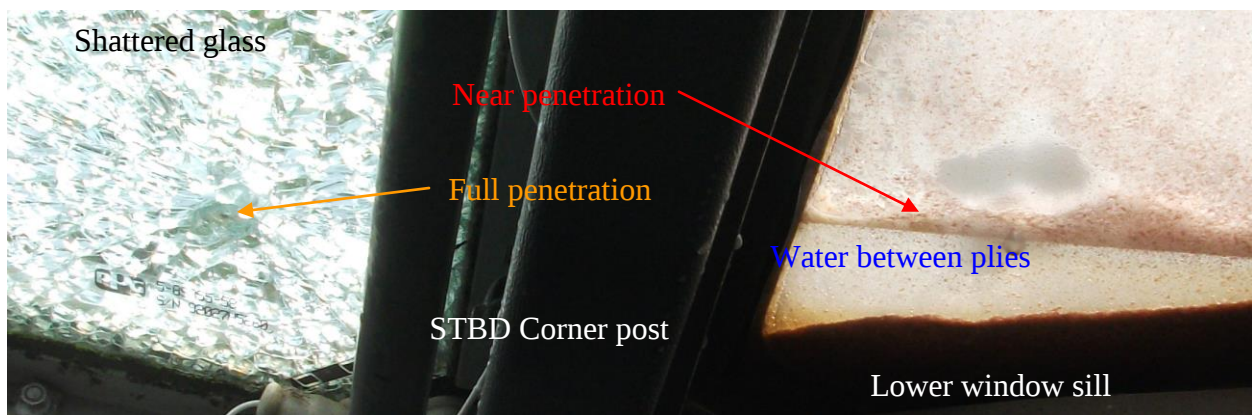
Fig. A.II-4. Interior view of STBD Cockpit windows.

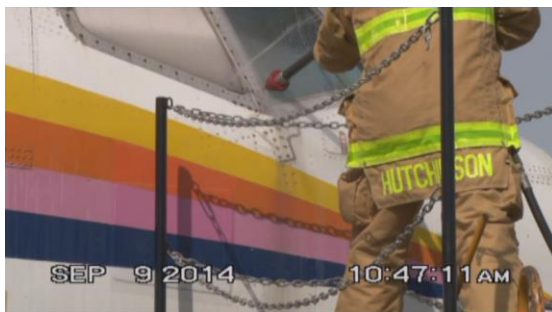
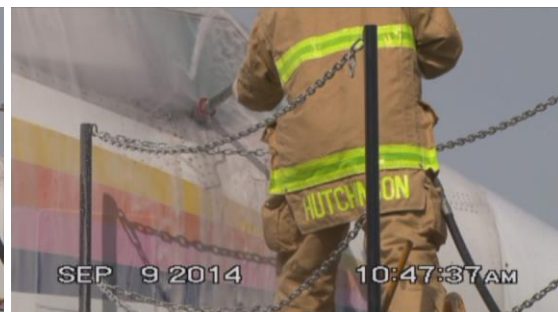
The front cockpit windshields are constructed as a glass panel laminate. These are very difficult to cut due to the multiple glass layers or punch through as they have a bird impact rating. The water jet abrasive media shattered the glass plies as expected (they are tempered) and pierced through the laminate thickness in 32 seconds (Fig. A.II-5.). Thus a rapid method of introducing firefighting agent into the cockpit was demonstrated.

Fig. A.II-5. STBD cockpit window (laminated glass). Duration: 0:32.

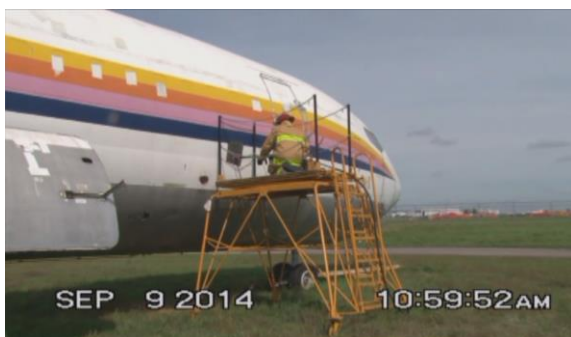
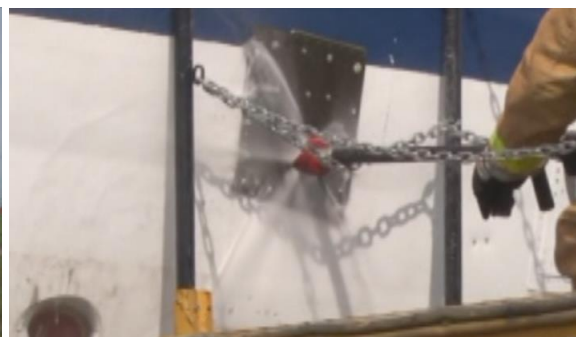
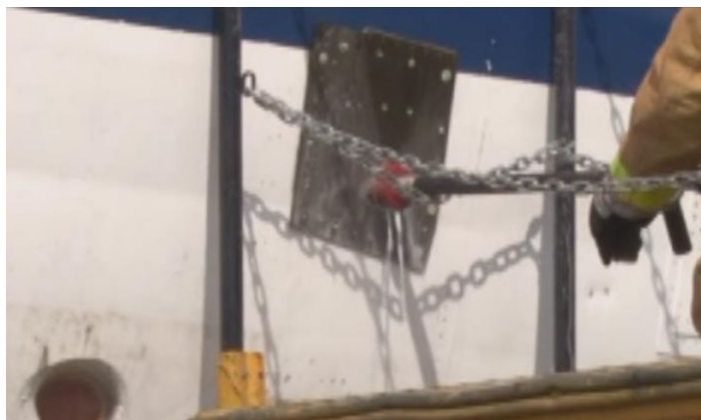
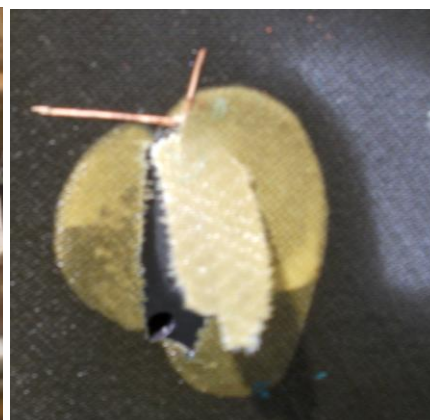
A panel of CFRP had been attached to the fuselage of the aircraft for Pyrolance demonstration. The aluminium skin behind the panel had been removed. The composite panel was nominally 0.3 inches thick. It was pierced and the stream of firefighting agent was introduced into the main deck area of the forward fuselage within approximately 6 seconds. The result was a very clean hole and only the inner fibreglass (anti-corrosion) ply was delaminated (Fig. A.II-6).

d) delamination of fibreglass ply

Fig. A.II-6. CFRP panel (0.030 inch thick). Duration: 0:06.

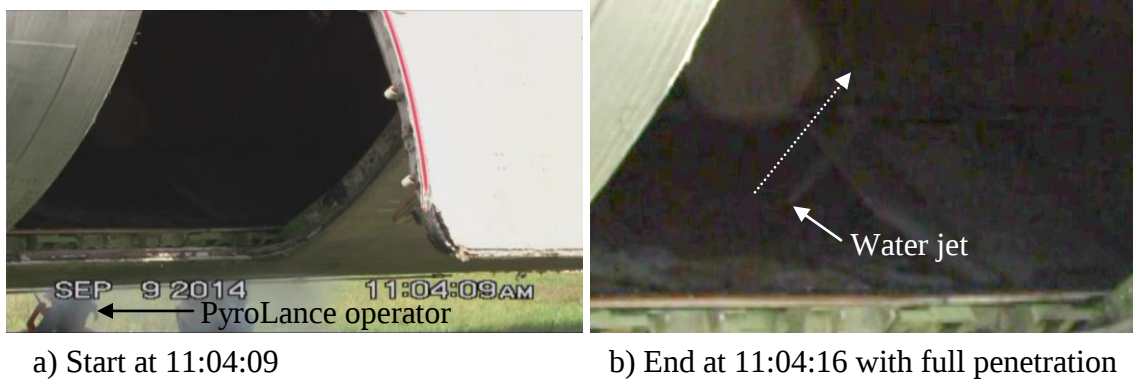
The PORT side of the FWD fuselage has an extra 0.1 inch thick (2.54mm) skin installed that surrounds the main-deck cargo door. This external skin doubler was installed over the existing fuselage skins and so a combined thickness of 0.145 inch (3.68mm) had to be pierced to accomplish penetration into the cargo hold, just above the floor and below the sidewall cheek area. Between the outer skins and the hold there exists only a thin fibreglass liner. The PyroLance succeeded in piercing completely and introducing a stream of firefighting agent into and across the width of the hold in seven seconds (Fig. A.II-7). This location is too low on smaller aircraft to permit a HRET Stinger piercing and too high on larger aircraft for expeditious manual piercing.

Fig. A.II-7. FWD Cargo hold. PORT side. Skins are 0.1" + 0.045" tk. Duration: 0:07.

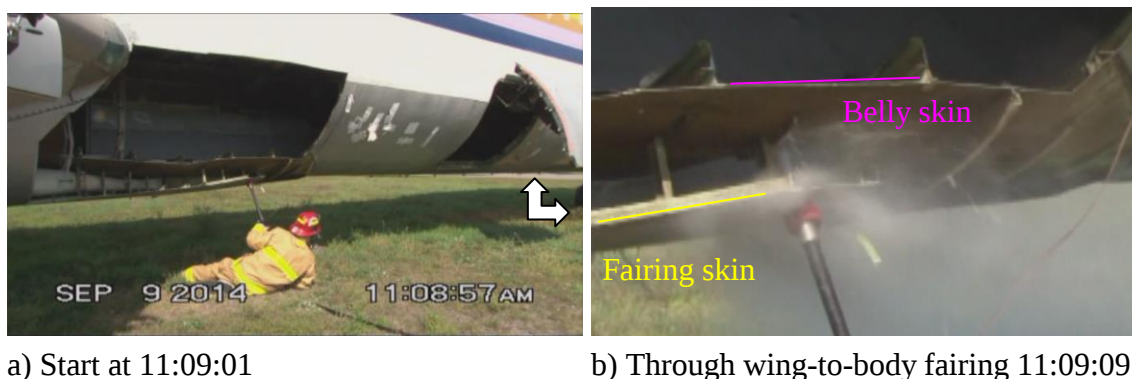
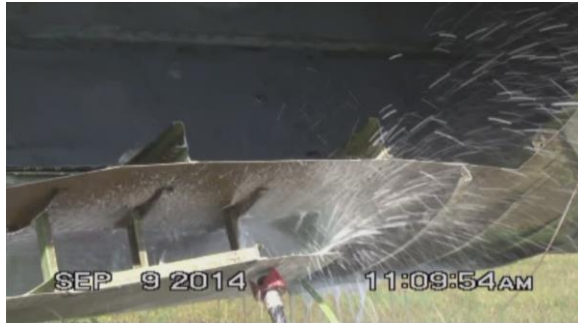
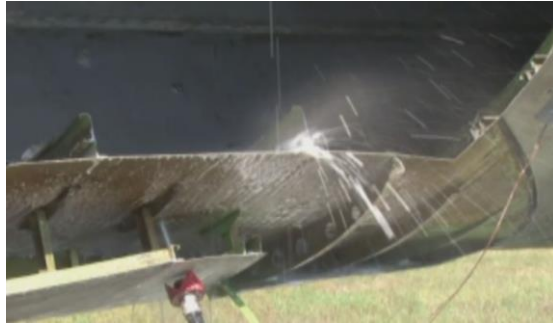
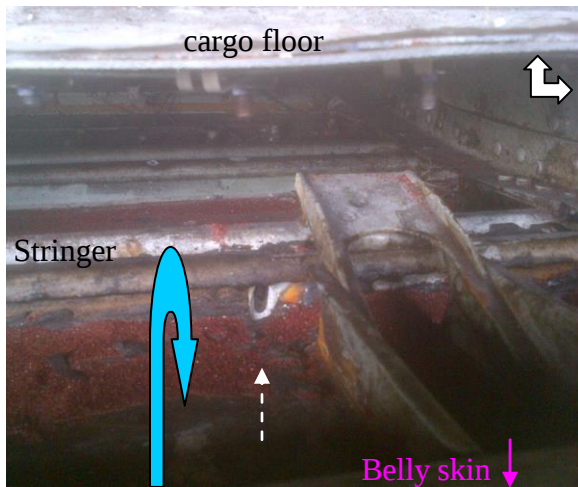
External access to the aft end of the FWD cargo hold (or FWD end of the AFT cargo hold) is obstructed by the wing-to-body fairing. A portion of the fuselage sidewall and fairing had previously been removed giving access to view the action of the water jet stream through the structural elements. The Pyrolance succeeded in piercing both the fairing (8 seconds) and fuselage skin within 53 seconds but the stream then encountered the side of a longitudinal stringer whose shape appeared to redirect the water stream although some erosion was accomplished. Piercing multiple layers at a distance from each other may have diffused the water stream and degraded its effectiveness. The trial was halted after 1:36 without piercing the cargo bay floor, Fig. A.II-8.

e) Water jet deflected by curvature of stringer flange. Did not penetrate flange or cargo floor.

Fig. A.II-8. Rear of FWD Cargo hold. STBD side. Floor skin not penetrated. Duration: 1:36.
